TECHNICAL TIPS MANUAL

Published By
International Aerobatic Club, Inc.
P.O. Box 229, Hales Corners, WI 53130 U.S.A.

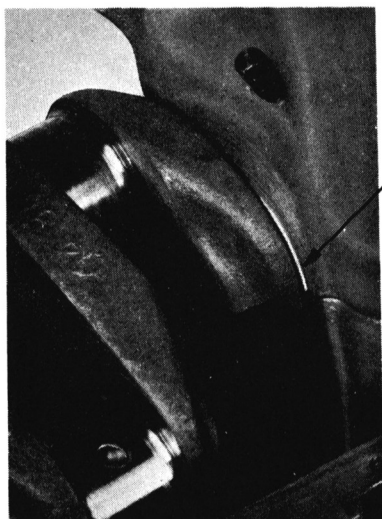
Figure 3. Area of Center Main Bearing as seen from Front of Engine (Abnormal Condition)

—Bearing protrusion of 1/32 in., as shown, at this location is indicative of progressive crankcase dowel failure. Exposed area of bearing appears greyish-white rather than "brownish." Bearing and dowel replacement is required before further engine operation.

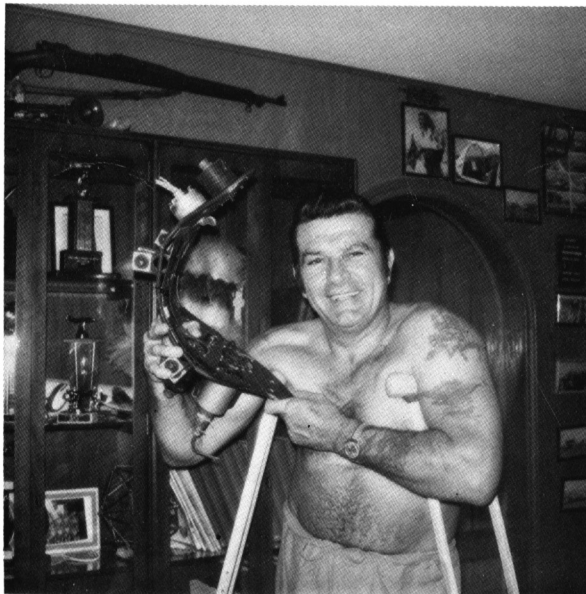
This is the instrument panel I stuck my head through. Originally it was straight.

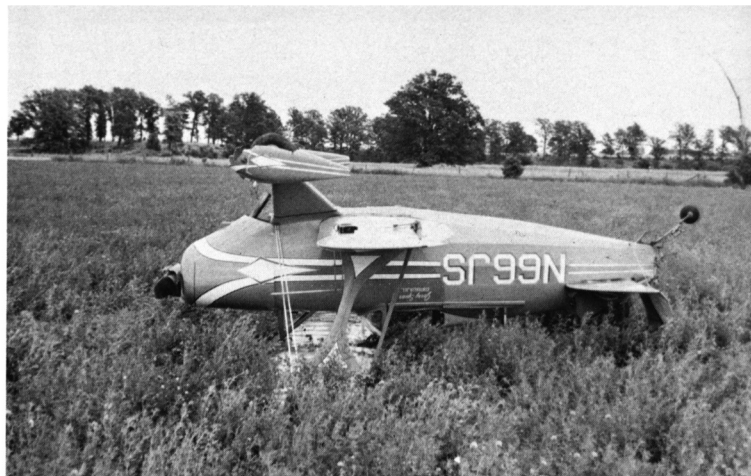
The result of the failure of a 25c pin in the fuel pump of Jerry Spear's Pitts.

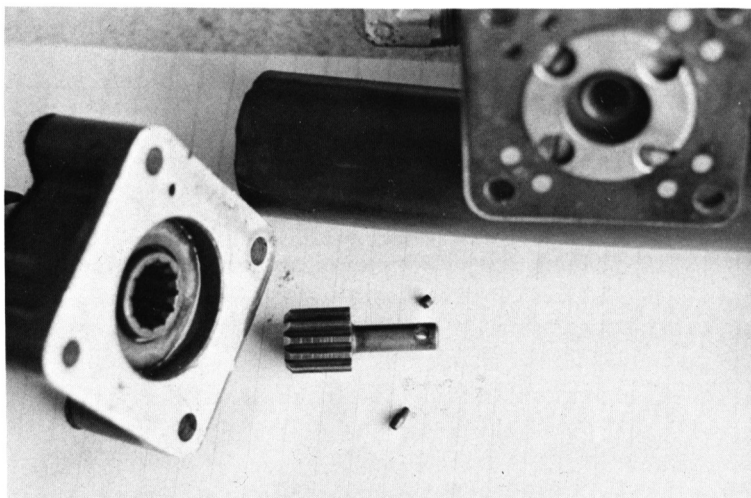
The culprit — note the failed pin that goes through the drive shaft on the Thompson TF-1900 fuel pump.

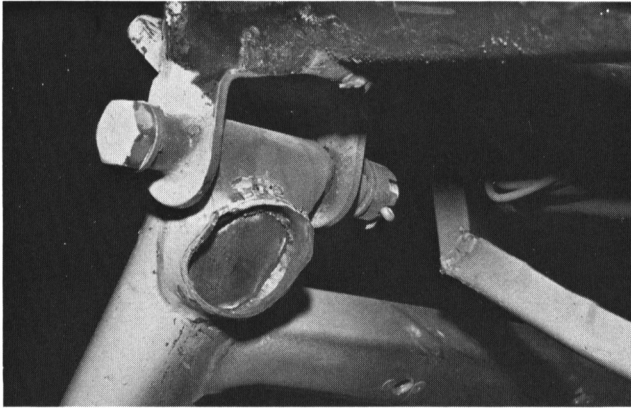
A close-up of the front top of the right MLG showing the point of failure. Note the weld is completely intact and the break occurred next to the welded area.

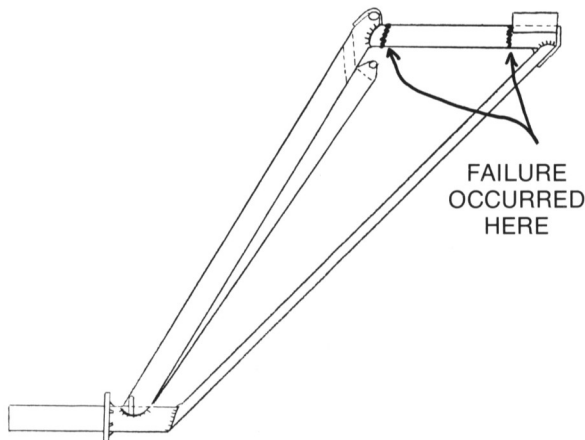
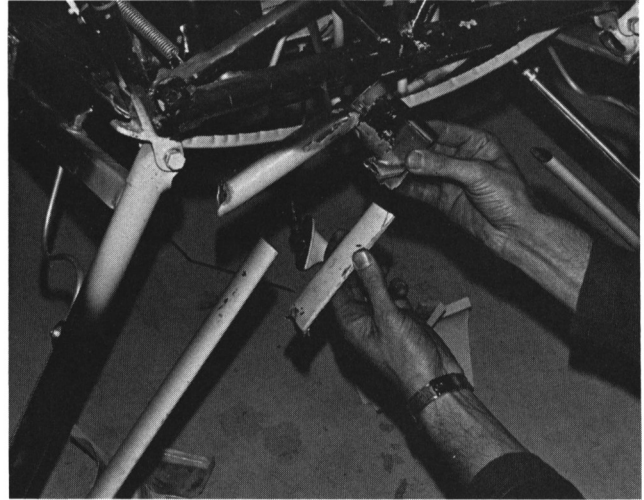
The relationship of the sections of failed tubing on the right gear leg.

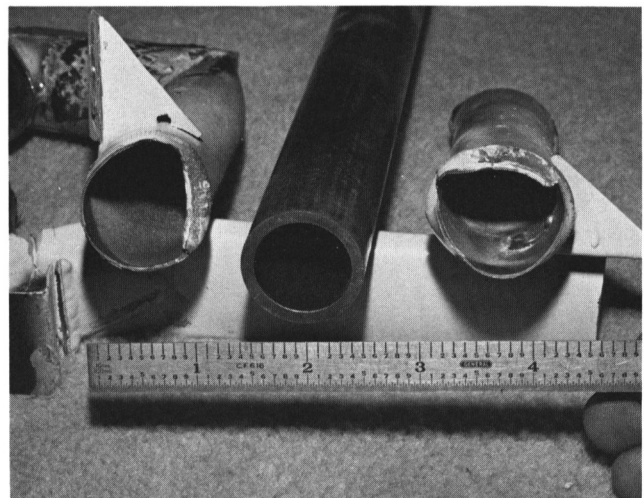
Dramatic illustration of the difference between the **early** 1.125" x .049 tubing (showing both ends of the failed section) and the **later** 1.250" x .120 tubing which replaces the same gear member.

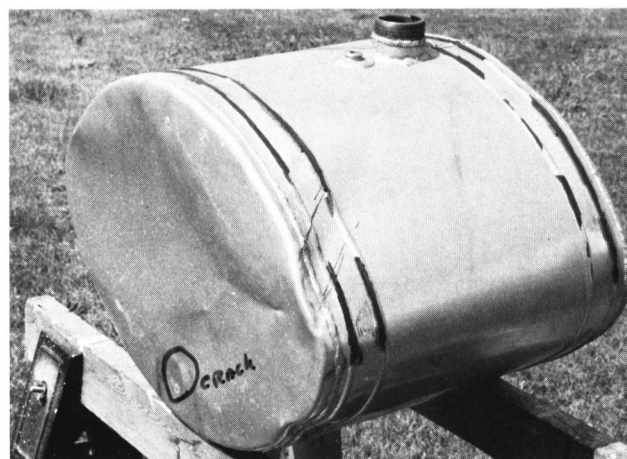
Consequently the crack in this particular Pitts fuel tank is believed to be the result of the original denting of the tank combined with flexing caused by pressure changes from a non-vented fuel system. This may be an isolated cause of fuel tank cracking but hope it may shed some light on what appears to be an increasing number of fuel tank problems in aerobatic airplanes.
