TECHNICAL TIPS MANUAL

VOL. II

Published By
International Aerobatic Club, Inc.
P.O. Box 2591, Oshkosh, WI 54903-2591 U.S.A.

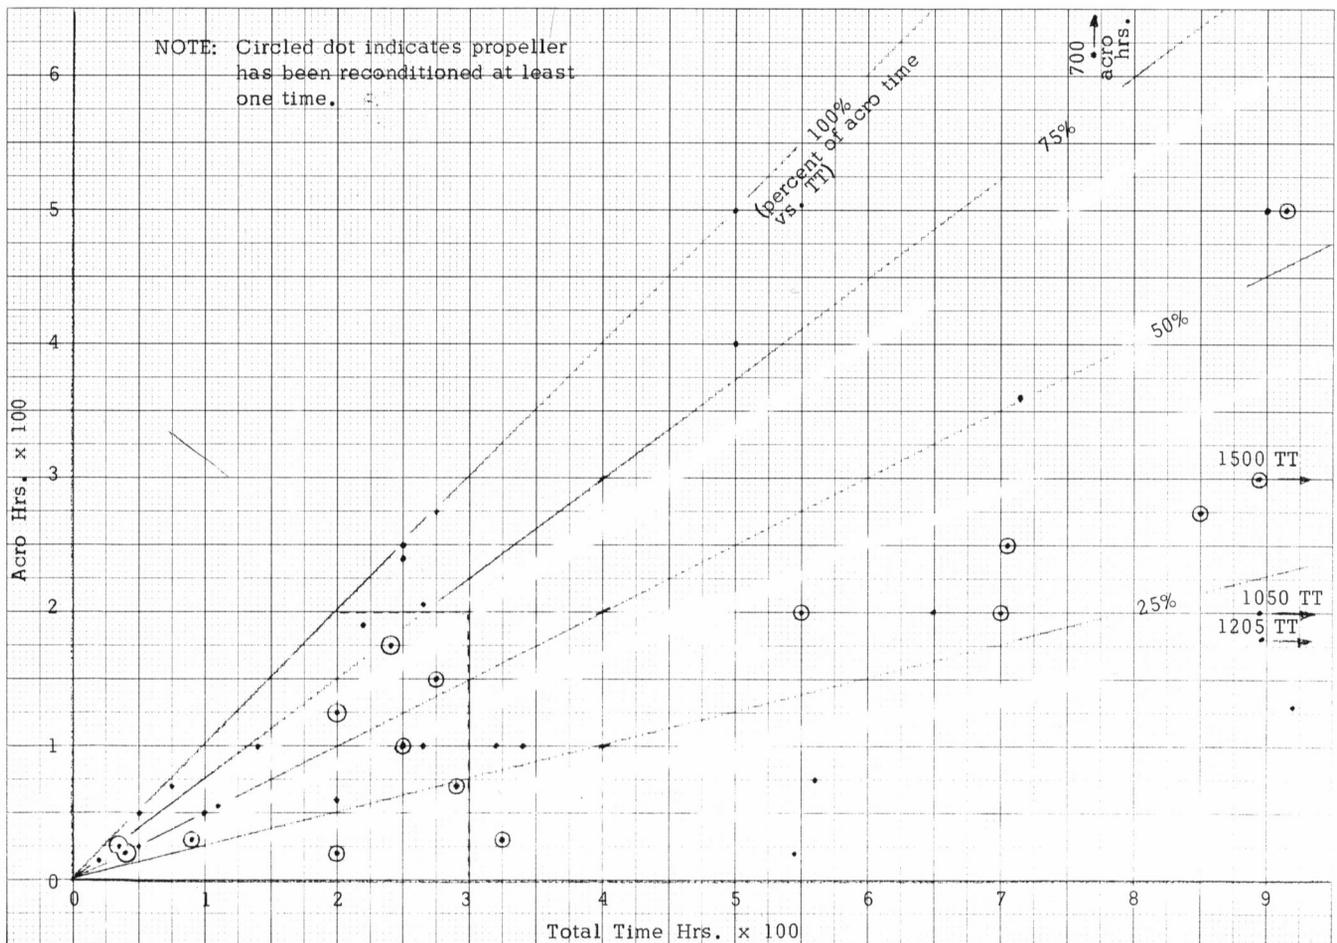
FIGURE 1

the 50% line would represent a prop that has spent half of its total time flying aerobatics. Dots lying between the 50% and 25% lines would represent props having between 50% and 25% of their total time in use in aerobatics. No reports of any fixed-pitch aluminum prop failures were received.

Note that 43% of the total prop reports fall inside a box bounded by 300 total hours and 200 acro hours. If this survey is representative of service life of fixed-pitch aluminum props used on acro aircraft, one might conclude that you would be fairly safe using a prop that

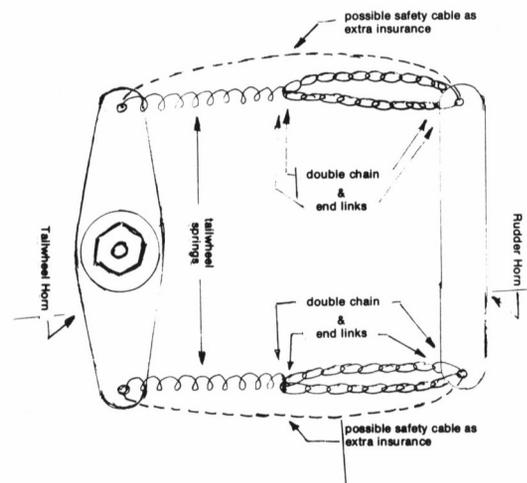
"A loss of a rudder tail wheel chain on a full swivel tail wheel prior to a crosswind landing could cause the full swivel wheel to swivel out with a complete loss of tail wheel control. I had an old Heath non-full swivel tail on my Pitts. The loss of the chain was disturbing but fortunately didn't cause a ground accident.

"The solution on the Pitts is to double up on all tail wheel steering chains and links. This gives a much lower probability of such a failure. An additional safety cable could be added as extra insurance.

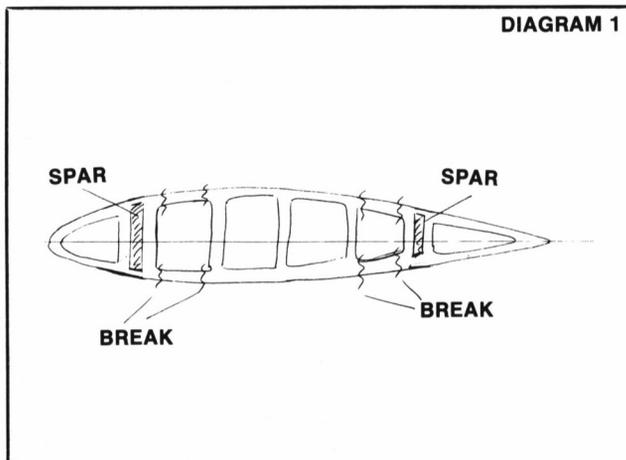
My particular concern is with a kind of rib which is frequently used as a substitute for the normal truss cap-strip rib. It is usually made of 1/4 inch thick 5 ply Douglas fir or mahogany and has four lightening holes in the area between the two spars to which it is attached with chinking blocks. When this type of rib breaks, in either upper or lower wing ribs, the failure seems mostly to occur in the area immediately aft of the front spar or ahead of the rear spar. Failures have been noted throughout the span of wings though usually starting in the I strut area.

You can check for broken ribs by pushing down or up on the fabric on the ribs in the area in question.

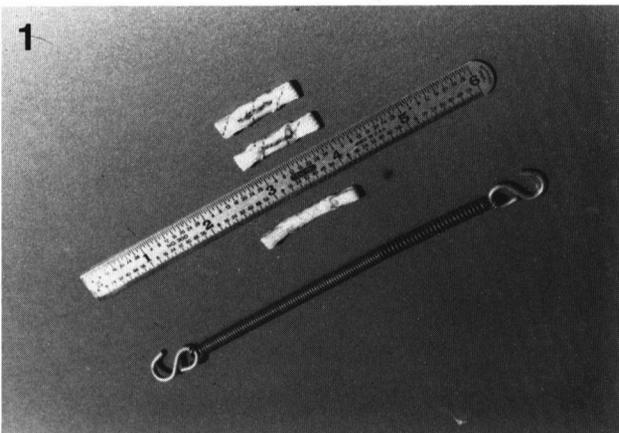
Photo #1 shows the woven loop (between the scale and the spring) which replaced the lacing cord. This woven loop has now been replaced with a **shorter** woven loop (the two loops below the scale are examples of the **latest** loop). (For those who use Security Parachutes, if you are not familiar with the location and/or function of the spring, S-hooks, and loops, please consult your parachute owner's manual and/or previous IAC parachute T.S. articles for details.)

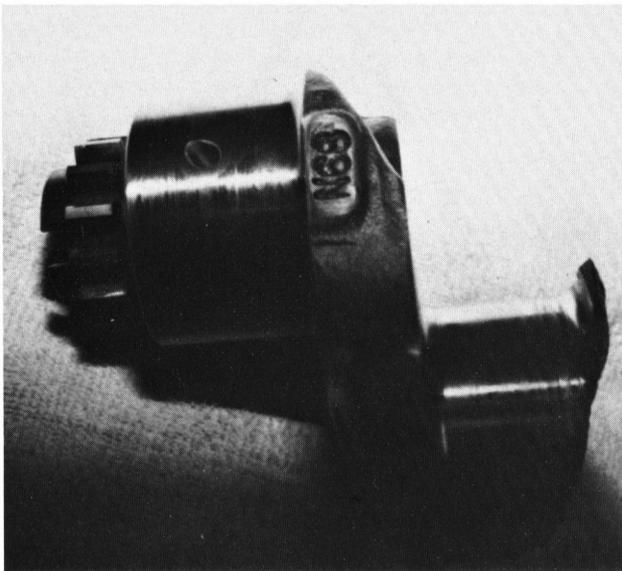
CRANKSHAFT!

Several months ago two IAC members were making some “touch and goes” in a recently completed Christen Eagle II. On the fourth take-off at about 150 ft. above the runway, a mild vibration ran through the airplane. The pilot advised that for an instant he thought it was just the common landing gear vibration sometimes experienced when the MLG wheels are still spinning after take-off and he started to apply the brakes to stop the wheel rotation. At the same time he noticed that the engine had lost power so he set up a forward slip to get the a/c back on the runway. Since they were operating out of a fairly short field, his intention was to ground-loop the a/c if it looked like they would run out of runway. After the a/c was back on the ground, it was evident that they could not stop on the remaining runway so an intentional ground-loop was attempted. However, the a/c was equipped with a locking tailwheel, which was in the locked position, so it resisted the attempted ground-loop. By this time they were at the end of the runway, so they “steered” between two posts, went 30 feet into a cornfield, and came to rest on the nose and right wing. The a/c did not flip over, there was no fire, and no one was hurt.

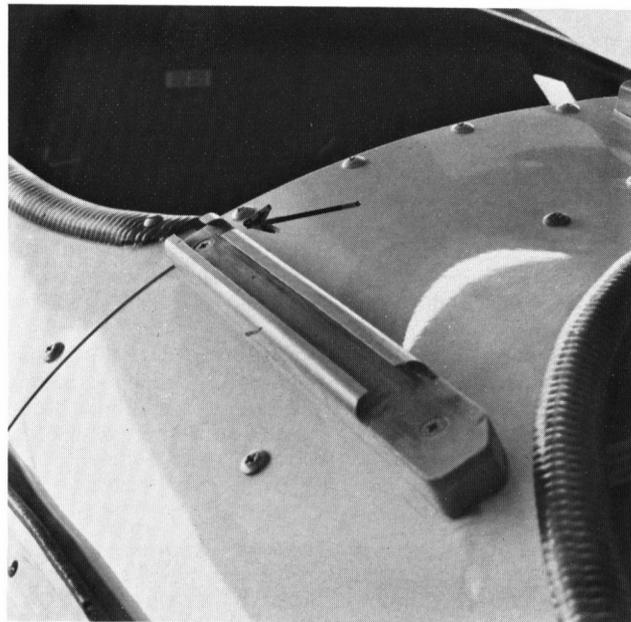
Arrow points to broken section of alignment rail (Pitts S2). Hinges on other side of cockpit were ripped from the plane.
