TECHNICAL TIPS MANUAL

Published By
International Aerobatic Club, Inc.
P.O. Box 229, Hales Corners, WI 53130 U.S.A.

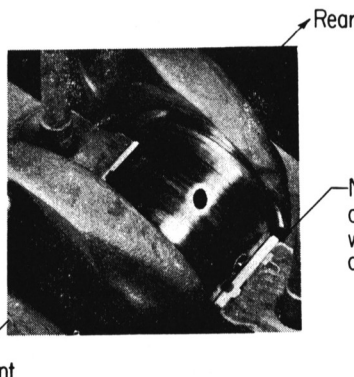
Figure 5. Left Half of Crankcase and Bearing Shell Removed to Show Position of Center Main Bearing (Abnormal Condition)

Note bearing shell in right half of crankcase has shifted rearward as result of worn dowel or bearing.

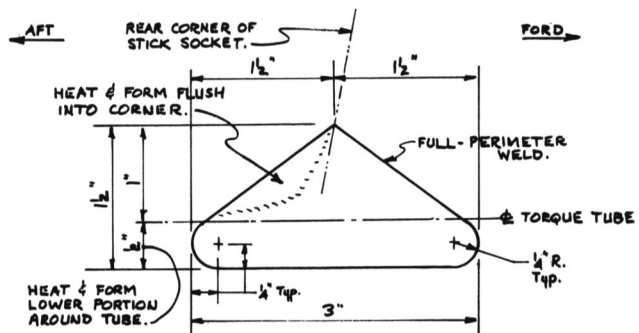
PITTS TORQUE-TUBE MODIFICATION
4130-N SHEET x .035 THICK - 2 REQ'D.
(ONE EACH SIDE; LEFT-REAR AND RIGHT-REAR, AT AFT JUNCTURE OF STICK SOCKET AND TORQUE TUBE.)

Inspect the control torque tube at the weld attaching the control stick bracket for cracks. If cracks are found replace the torque tube assembly using a 1½ x .035 x 4130N main torque tube. Assure that weld areas are not overheated and have good penetration.

Originally we used 1½ x .028 tubing for this part. This has been changed to 1½ x .035 x 4130N tube. I have checked Sam Burgess' tube which was 1½ x .028 with indication of overheating of the weld and tube in the area where the failure started.

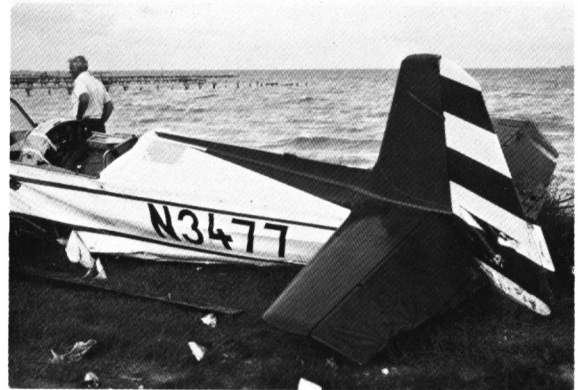
The wreckage of the Zlin up on shore.

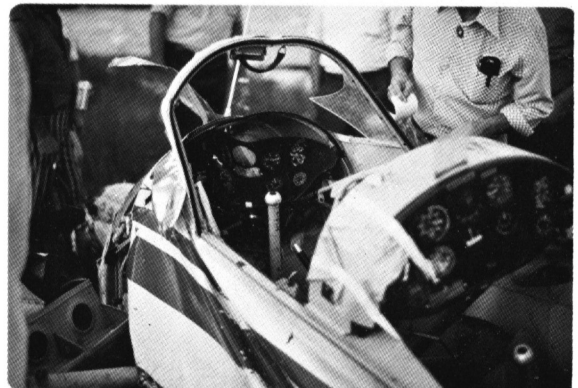
This is the instrument panel I stuck my head through. Originally it was straight.

The cockpit I was in. Note the instrument panel.

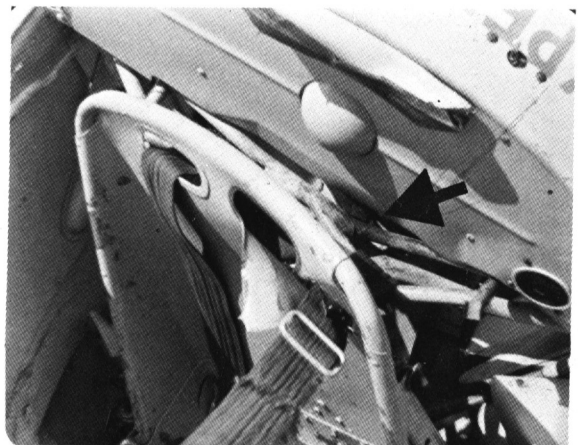
The main reason I am sending you these pictures is to show you the force with which I hit and to show you how the shoulder harness saved my life. I hit with such force that the straps ripped loose a welded cluster of $\frac{5}{8}$ " and $\frac{3}{4}$ " tubing. Even with the harness stopping me I bent the instrument panel almost double. If I hadn't used this harness I would have eaten the back of the engine and

A close-up of the welded cluster that was bent by the force of the crash. The shoulder harness saved my life.

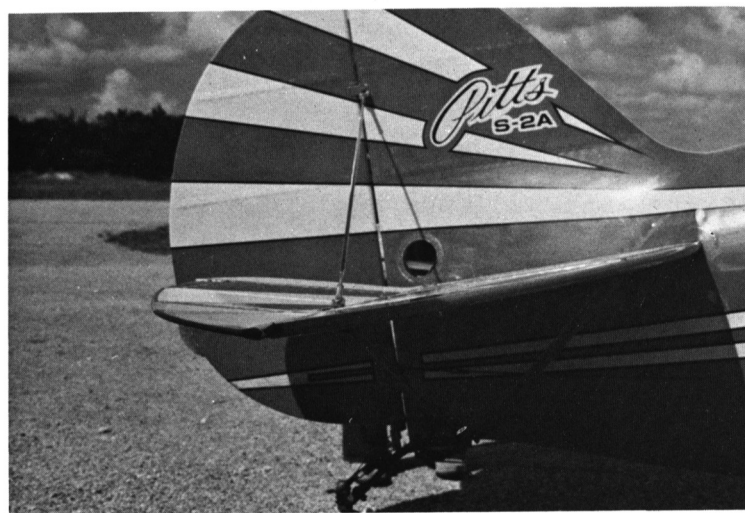
This was all the up-elevator available, with the control jammed in the S-2.

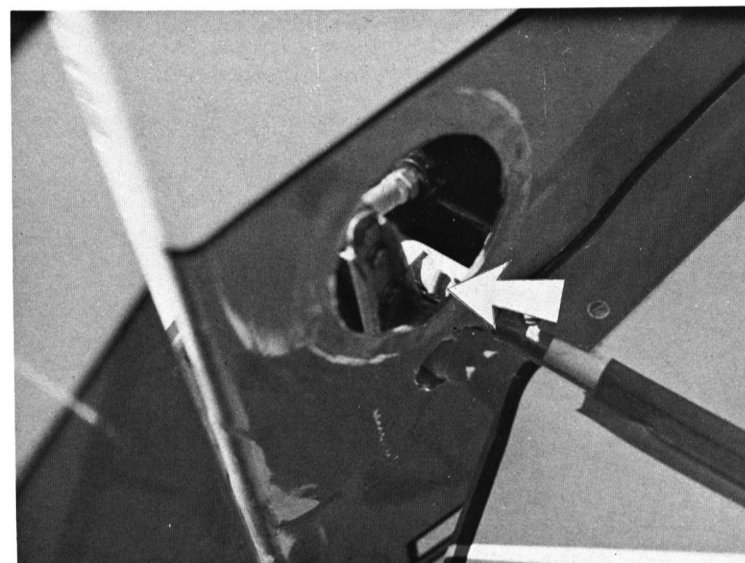
Did something just fall onto the cockpit flooring? Maybe . . . well, I guess not . . . don't see anything. A missing screw after minor work? Forget it . . . got another one here in the box. Where the hell is that little screwdriver? Probably left it over there on the tool bench.

P.S. I know where the number 10 came from and the mechanic and I have discussed the situation.

Note the No. 10 screw jammed between the tubes.

DON'T GUESS! Find the missing screw. Find the screwdriver. Pull the inspection plates and drop a hand or strong magnet into those inaccessible sports that the eyeball cannot reach!! It sure saves wear and tear on the pucker factor.

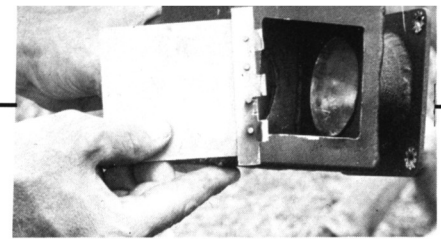
The culprit — this is the alternate air door which wore out and blocked off air to the engine. It lodged itself over the round intake visible through the box.

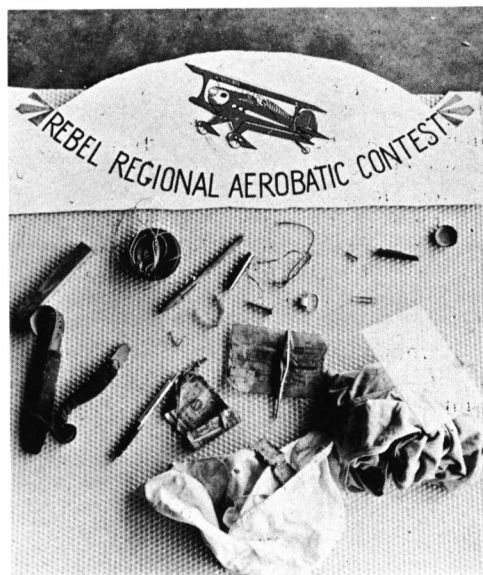
Loose objects inventory (shown in photo)

Block of wood ($\frac{3}{8}$ x 1 x 6)
Rubber earcup from headset
Ball of string
2 ballpoint pens
2 ballpoint pen caps
Gob of safety wire
Plastic harness strap
2 sheet metal screws
Coke bottle cap
Pop can pull tab
Paper clip
Aircraft bolt
2 helmet straps
Gas ticket
Parachute packing card
Pair of tweezers
Piece of plexiglass
Greasy rag
Knit shirt

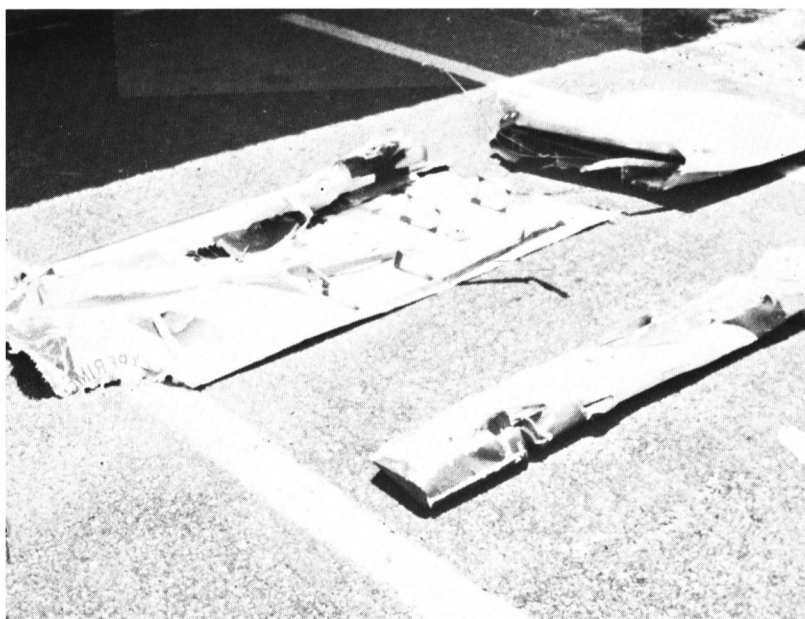
Left top wing and left lower aileron.

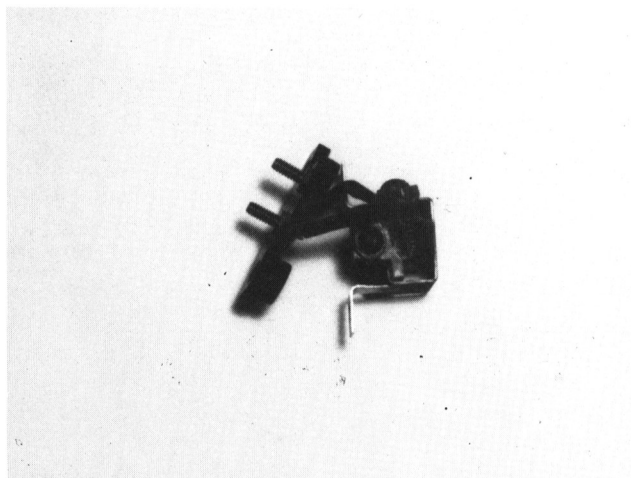
ALTERNATOR BRUSH HOLDERS

An IAC member recently encountered an alternator malfunction due to a broken alternator brush holder. A little research revealed several other broken alternator brush holders, namely:

Year	Make & Model	Total Time
1973	Citabria 7ECA	20 hrs.
1973	Citabria 7GCBC	—
1972	Decathlon 8KCAB	135 hrs.
1969	Citabria 7ECA	308 hrs.

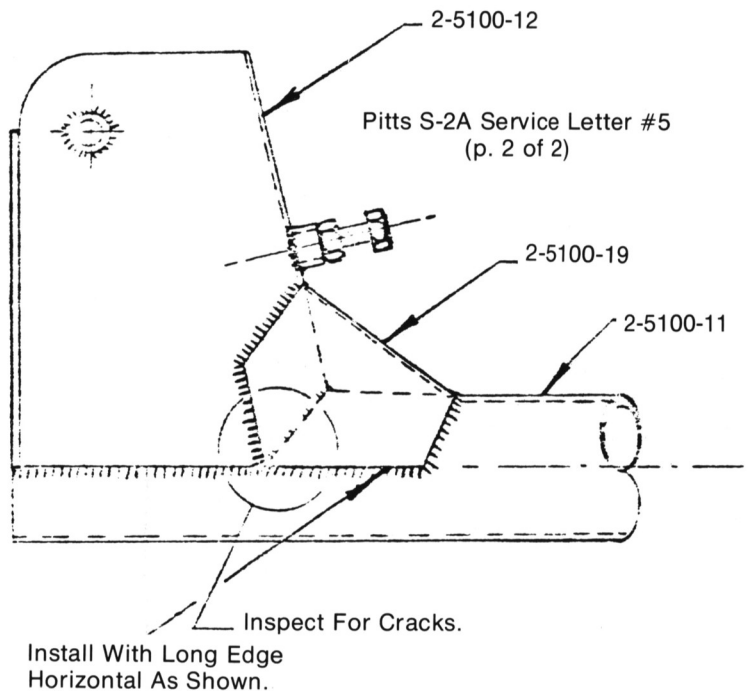
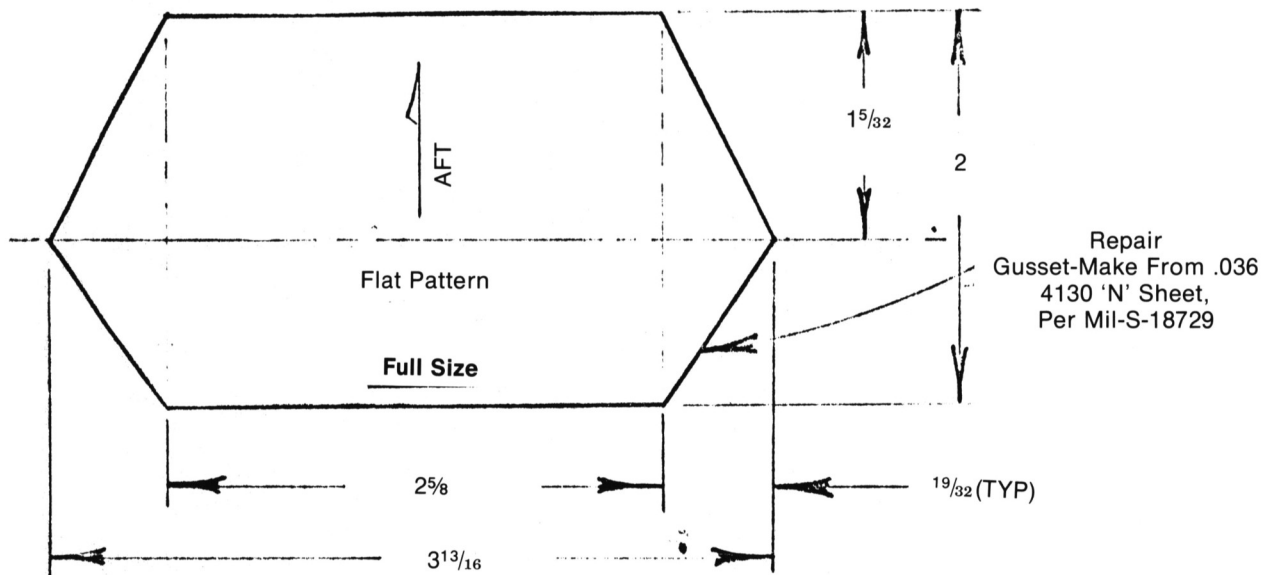
DISCUSSION: We have had a few reports involving airplane subject to frequent and vigorous aerobatics concerning cracks initiating at the junction of the aft 2-5100-12 stick housing, where it is welded to the 2-5100-11 tube. (The 2-5100 control tube assembly connects the front and rear control sticks.) It is reported that having started, the cracks progress slowly.

ACCOMPLISH THE FOLLOWING: This area is easily inspectable without removal or disassembly of parts. Strip paint from the suspect region and inspect for cracks using a ten-power magnifier. If no cracks are noted repaint the stripped area and repeat this inspection each 100 flight hours. If cracks are noted, remove the 2-5100 control tube assembly from the airplane, weld shut the cracks, and weld on reinforcing gusset, P/N 2-5100-19, per repair sketch enclosed with this letter. Note that both ends of the 2-5100 control tube should be inspected, although no cracks have been reported at the forward junction between 2-5100-12 housing and 2-5100-11 tube. After repair, the reworked areas should be repainted. All welding and priming/painting to be in accordance with good aircraft practice, per FAA AC 43.13.1. Please advise Pitts Aviation Enterprises, Inc., P.O. Box 548, Homestead, Florida 33030, of the results of your inspection, and the total airframe time on your airplane. Part no. 2-5100-19 gussets are available from Aerotek, Inc., P.O. Box 547, Afton, Wyoming, 83110.

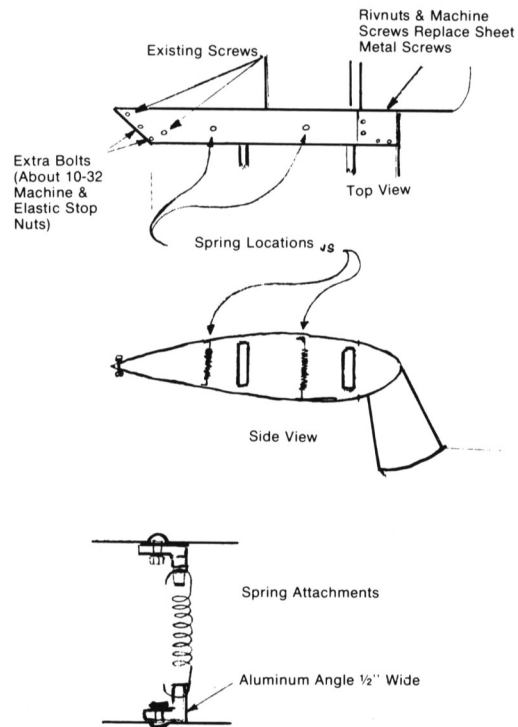
Citabria & Decathlon Fairings

Wing root fairing problems have been reported by several Citabria and Decathlon owners. (Remember Dennis Houdek's article "It Quickens the Pulse" in June 1977 *Sport Aerobatics*). One IAC member sent in the following comments and shop sketch on how he remedied the situation.

"Thank you for forwarding the information from your IAC member concerning the Decathlon gap cover problem. We have a production fix for this problem coming out in our 1978 model which I am sure will please everyone. We are now in the process of developing a service kit for field retrofit. I have passed your suggestion onto our Osceola Engineering Staff. Our Service Department will send you a copy of this kit when it is available."

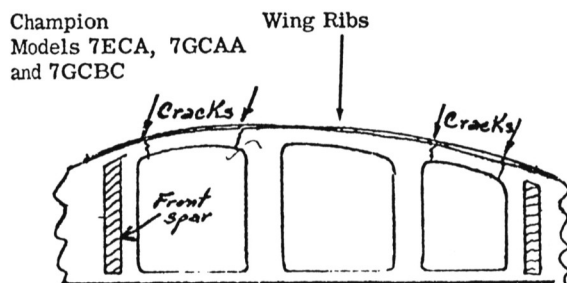
With reference to the Champion wing rib failure item which was published on page 41 of the 1968 General Aviation Inspection Aids Summary, it is now reported that there have been additional occurrences.

Champion Service Letter No. 93 contains detailed information on this problem and prescribes Champion Service Kit No. 232 be used if cracks are found.

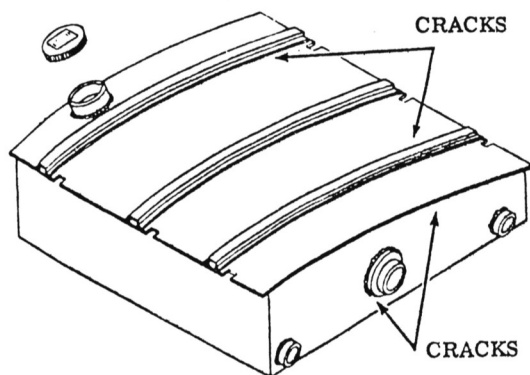
There are numerous reports that fuel tanks are leaking at the welded seams, baffle spot welds, and adjacent to the fuel gauge. The leaks are evidenced by stains or seepage at the wing trailing edge.

A tank designed to withstand the loads imposed by aerobatic maneuvers is available from Champion. Their Service Letter No. 89 identifies applicable models and describes ordering procedures.

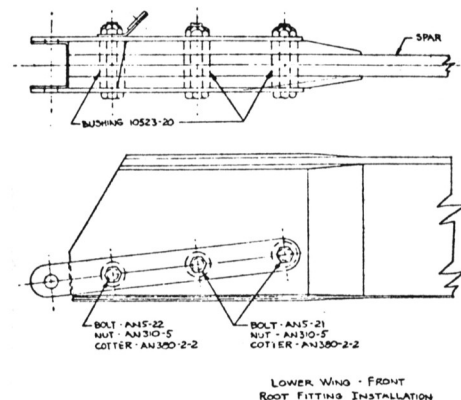
TYPICAL BUSHING INSTALLATION
AT N-STRUT & BUTT-END FITTINGS

Intergranular corrosion was found in the spar crush bushings in all wing fittings of a Waco Model UPF-7 aircraft during overhaul. The corrosion was most prevalent in the lower wing at the root and "N" strut fittings. It is recommended that these areas be examined very closely during inspections. The bushings are a close press fit and can be removed by using a wooden dowel and a hammer. If they are seized, this is a good indication of expansion caused by intergranular corrosion. When this occurs, the spar holes should be checked for elongation caused by expansion of the bushing. It may be necessary to remove the reinforcing plates to accomplish this inspection. If the spar holes are elongated it may be necessary to replace the entire spar.

These conditions may exist in other models of Waco aircraft or other aircraft of similar design.

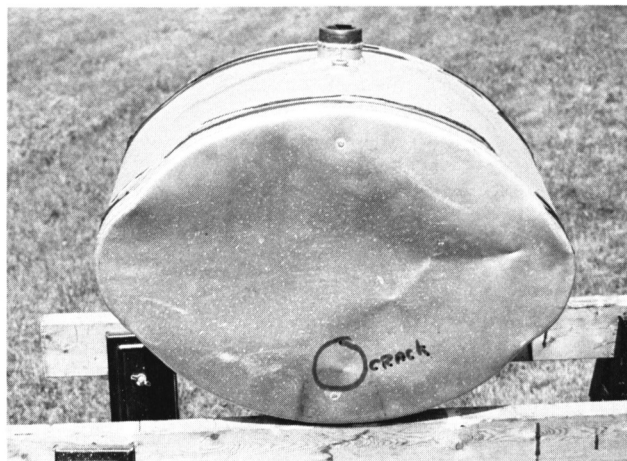
1. The fuel tank was severely dented during the building stage to facilitate its clearing the aft cabane struts, which set up stress wrinkles on the aft side of the tank. (see picture) After 200 hrs. of flexing and vibrating one of these areas gave away.
2. Using the normal non vented fuel tank cap for inverted flight the only venting available is through the standard vent line along the landing gear. Now, many things frighten aerobatic pilots: 200 ft. Lomcovaks, Advanced and Unlimited Unknowns, loose women, ????? and mud dobbers. To alleviate danger from the latter we cover pitot tubes etc., and on this Pitts we even covered the fuel tank vent line with a sealed plastic tube. (see picture) Imagine the pressure build up in the tank after filling it with fuel on a 40 degree evening and then

having it sit in a 90 degree hangar the following day. These temperature ranges are not uncommon in New England or many other places during the Spring and Fall. With no venting available the pressure changes in the tank must have been substantial, and in this case caused much flexing on an already wrinkled and weakened tank surface.

Consequently the crack in this particular Pitts fuel tank is believed to be the result of the original denting of the tank combined with flexing caused by pressure changes from a non-vented fuel system. This may be an isolated cause of fuel tank cracking but hope it may shed some light on what appears to be an increasing number of fuel tank problems in aerobatic airplanes.

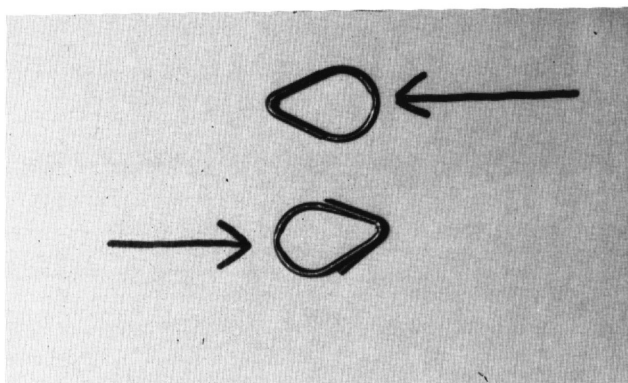
One IAC member sent the IAC T.S. Committee some worn tailwheel chain spring clips off of his S-1 Pitts. (See Photo #1) He advised these clips had approximately 300 hrs. of use with the large Cessna-type springs. He also suggested the following: "Always install the clip in the tailwheel actuating armhole with the twin end pieces attached to the chain — the round end (of the clip) should be inserted in the actuating arm to cause less wear," and he further commented, "... it is a good procedure to run a couple of lengths of safety wire around the spring and chain where they join — if the chain should wear here and break, the safety wire should hold and prevent a serious mishap."

Tail wheel chain spring clips from Pitts S-1.

Another IAC member who had the above mentioned clips on his S-1 Pitts break — which resulted in wheel fairing and wing tip damage — noted that these spring clips are made of a pretty hard material and they wear only to a certain point and then **snap**. If a spring clip is worn 25% of the way through, this does **not** mean you have 75% of wear left — it may snap in half on the next landing.

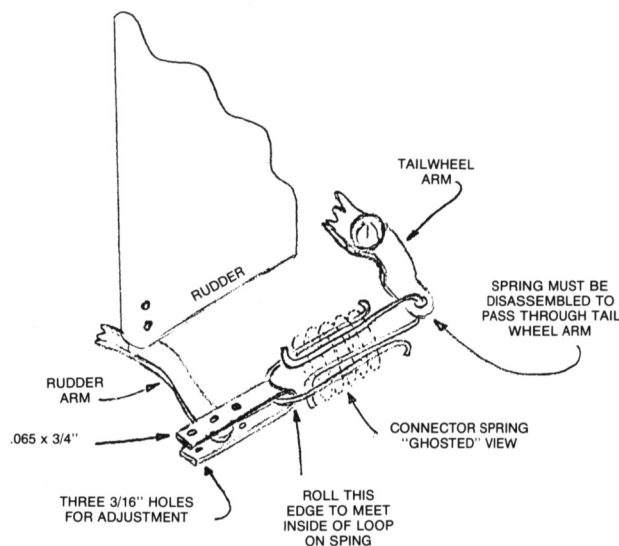
Still another IAC member eliminated the spring clip/chain problem altogether. (See Sketch #1) He advised he has used this set-up on both of his 8KCAB Decathlons satisfactorily.

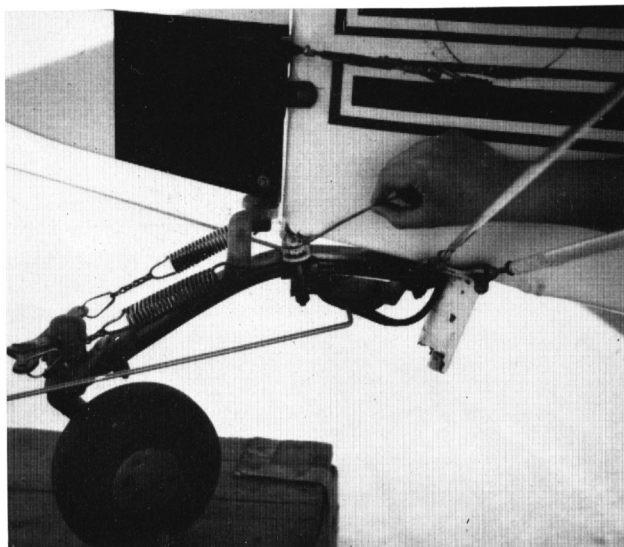
Photo #2

- Wider tailwheel springs are usually less prone to shimmy than the narrower $1\frac{1}{4}$ " wide springs.
- Shimmy problems are sometimes due to loose spring throughbolts or loose spring "U-bolts".
- Shimmy problems are sometimes related to over-inflated pneumatic tailwheel tires. If a shimmy problem exists, he recommends trying tailwheel tire pressures of 15-20 PSI.

- Be sure and check steering arm on rudder for tightness.
- New Maule tailwheels do not incorporate shimmy dampers.
- Maule is now manufacturing a new type of tailwheel connector springs. These springs consist of one "light" spring and one "heavy" spring. It is recommended that the "heavy" spring be installed on the right side because of engine torque. These springs are intended to help eliminate tailwheel shimmy and vibrations. (It should also be noted that Mr. Maule **donated** a set of these springs to the IAC for evaluation.)

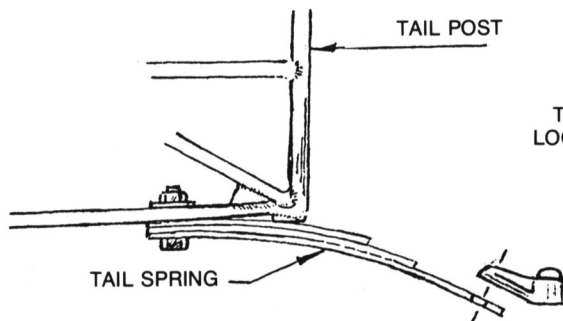
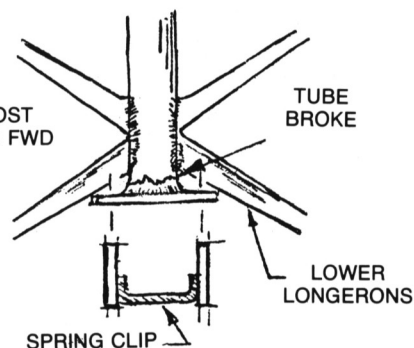
Sketch #2

Two S-2A Pitts have suffered broken fuselage lower tailpost plates. In one case (See Sketch #2) an IAC member reported, "During a slight crosswind landing, the tire started to vibrate severely enough to be felt over the entire airframe causing the lower tailpost plate to separate. Directional control was lost momentarily — pilot was proficient enough to regain control avoiding serious damage to aircraft." On the second S-2A Pitts (See Photo #2) another IAC member reported, "It was noted upon preflight that the tailwheel would wobble when the fuselage was pushed sideways. Subsequent inspection revealed the tubing was cracked $\frac{3}{4}$ of the way around with a possible small wedding band just above the crack." Please note that this second aircraft was just recently purchased and the past history was not known, however it seems very possible that tailwheel shimmy/vibrations could account for the broken tailpost plate. This area should receive close inspection on all S-2s and possible other a/c as well. Pitts Aerobatics advises that a gussett plate was installed in the tail post area to production S2A aircraft ser. #s 2126 and up — which means it was incorporated about 2 years ago.

Name of Specific Part Causing Problem	Mfg. & Part #	Part Condition	Part Total Time
Tail Post Spring Bracket		Separated From Aircraft	560 Hrs.

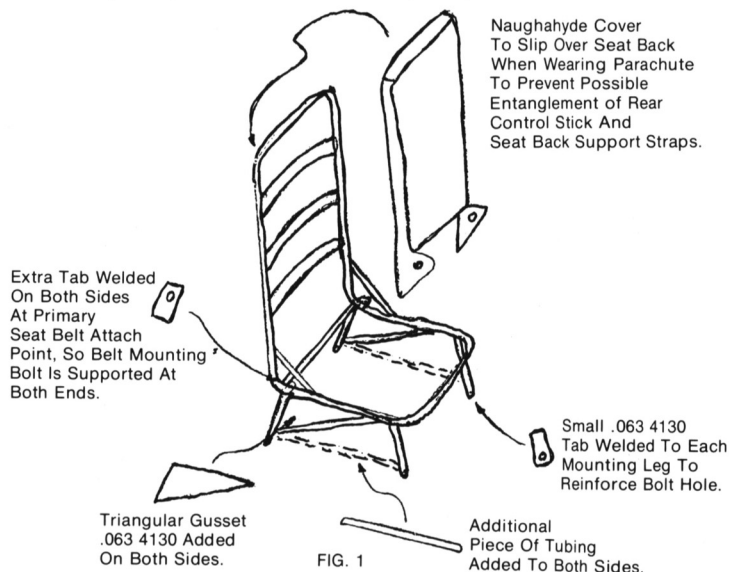
"I noted in the March, 1978, edition of *Sport Aerobatics* a report of a Citabria having had structural failure of a seat frame. This is to report a similar structural failure on my 1975 7KCAB. The metal fatigue occurred on both sides of the tubular structure at the point of attachment to the rest of the seat by bolts. The right side fractured first and the left side was badly weakened with the usual appearance of metal fatigue.

Although it is "second guessing" on our part, from the member's description of his seat breakage point, we believe the break was "more similar" to the 1976 8KCAB problem reported in the May 1977 issue of *Sport Aerobatics* where "... The seat back failed — on the right side. The hinge bolt tore through the mounting fork." Obviously, the most important point of this discourse is to make IAC members aware of the potential of seat breakage and to encourage, as part of pre-flight inspections, a close examination of the aircraft seat.

Another IAC member who owns an early 7ECA with the standard, non-folding back, non-adjustable seat, advised that although he has encountered no seat breakage problems he has made the following seat modifications as precautionary measures. (SEE SKETCH #1)

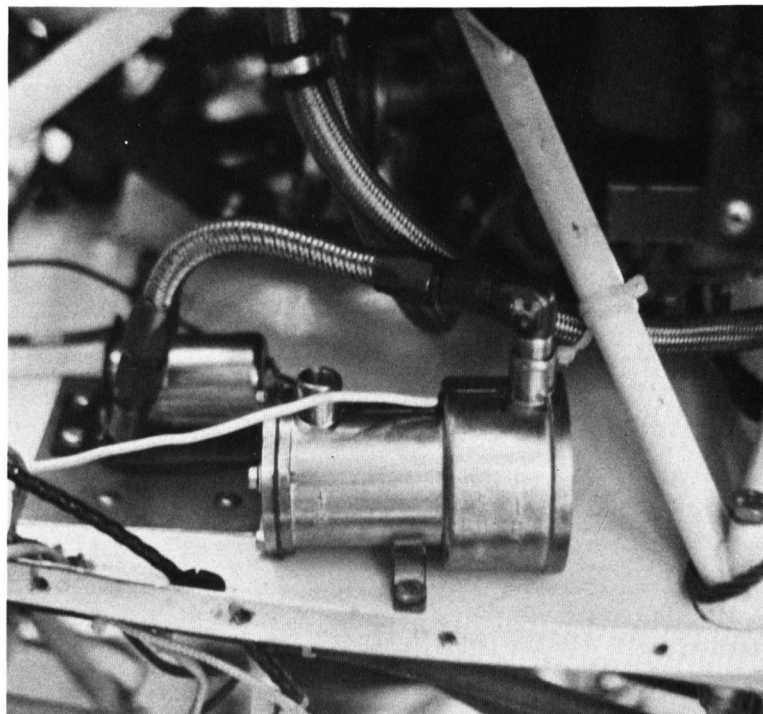
NOTE: Prior to developing the above system, a Thompson TF-1900 pump was used, mounted on the engine. Due to lack of adequate lubrication this pump frequently failed. Also the high pressure lines ran into the cockpit where the switch was. On one occasion failure of the line caused the pump to fill the cockpit with oil spray, making it hard for the pilot to see. The electric system above avoids these problems.

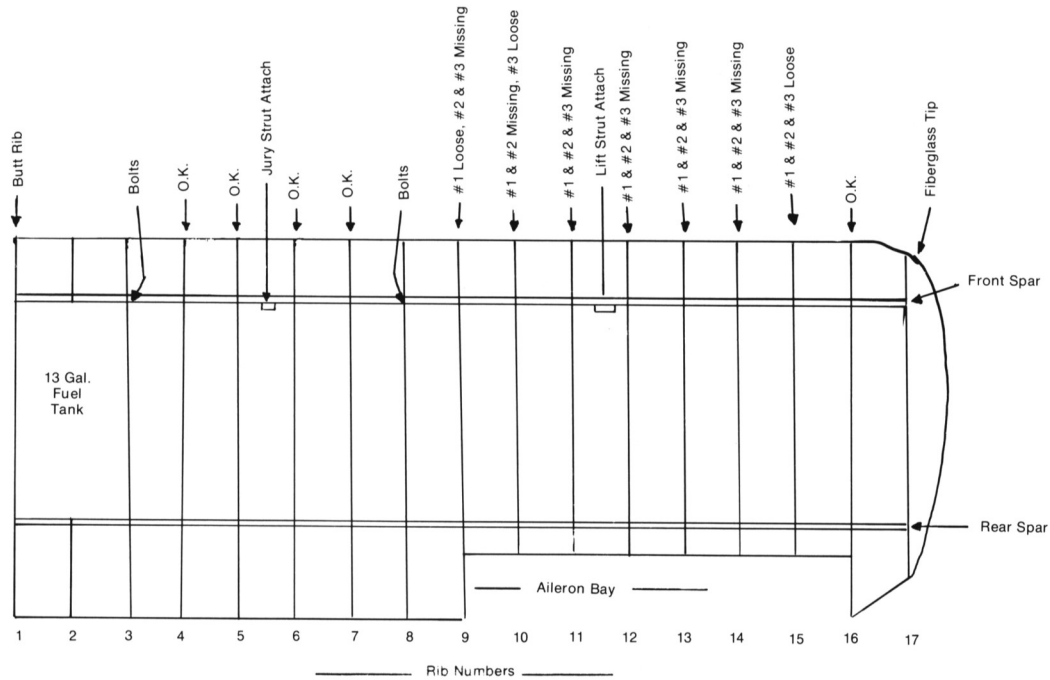
FIGURE 2

RIGHT WING
 • 16 Nails Missing
 • 5 Nails Loose

*No Missing Nails Recovered
 *All Rib To Rear Spar Attachment
 Nails O.K.

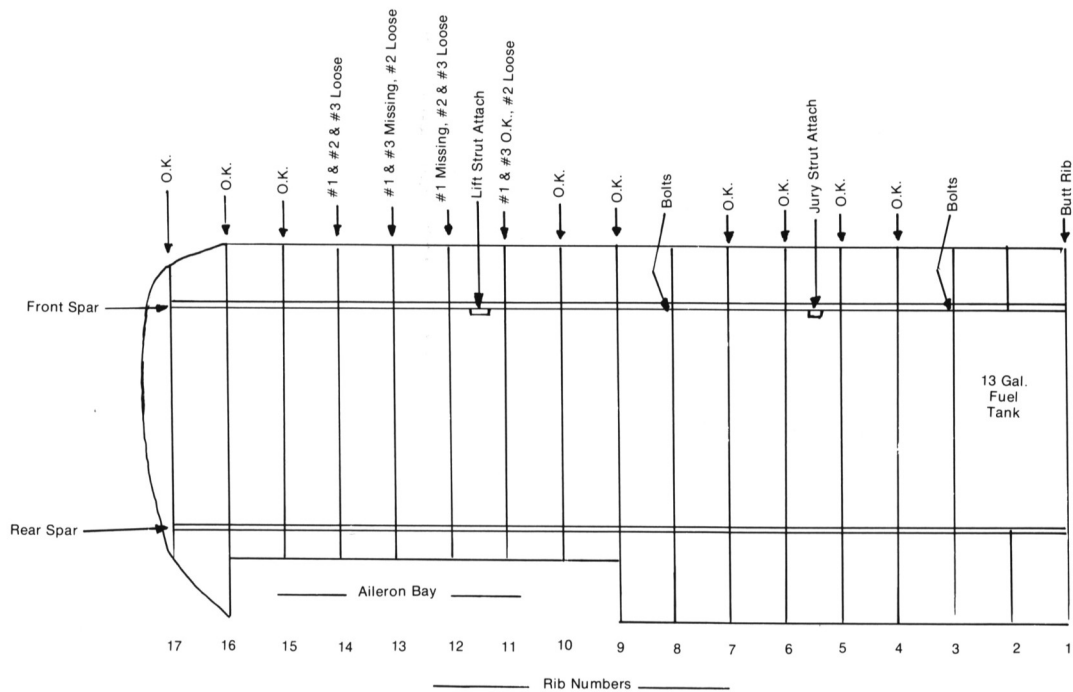
FIGURE 3

LEFT WING
 • 3 Nails Missing
 • 7 Nails Loose

*No Missing Nails Recovered
 *All Rib To Rear Spar Attachment Nails O.K.

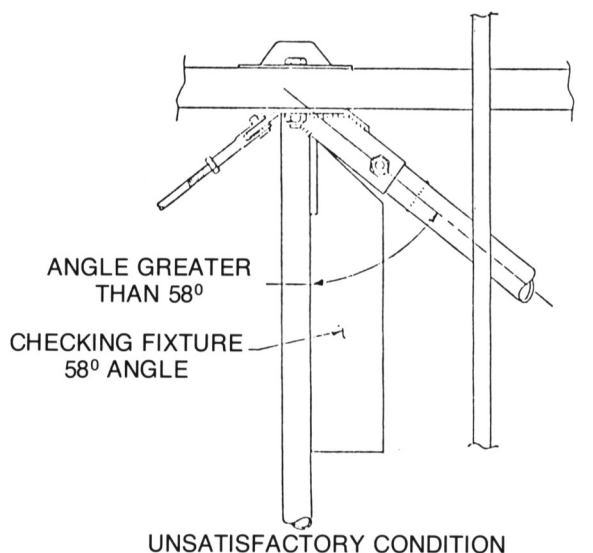
FIGURE 1: MEASURING ANGLE BETWEEN COMPRESSION TUBE AND DIAGONAL STRUT SOCKET

1. Remove forward inboard inspection covers just outboard of fuel tanks. If these inspection covers are not installed, cut out fabric inside inspection grommets in this area.
2. Measure the angle between compression tube and diagonal strut socket as shown in Figure 1. This angle may be measured using a prefabricated template supplied by Bellanca (P/N 1A32) or a template as shown in Figure 2.
3. If the angle between the compression tube and the diagonal strut is equal to or less than 58°, no repair is necessary. If the angle is greater than 58°, repair per Service Kit No. 270.
