TECHNICAL TIPS MANUAL

VOL. II

Published By
International Aerobatic Club, Inc.
P.O. Box 2591, Oshkosh, WI 54903-2591 U.S.A.

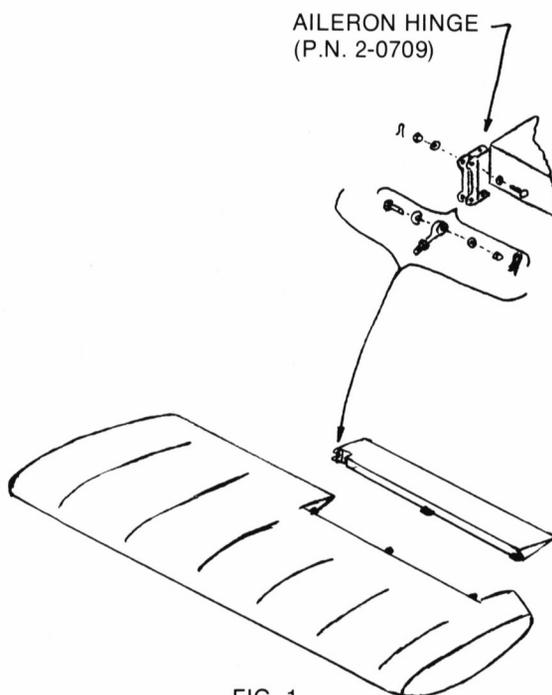
FIG. 1

It is suggested that all IAC Citabria pilots make a thorough inspection of the aileron hinges on their a/c. If any problems are uncovered, please make an immediate report to the IAC T.S. Committee.

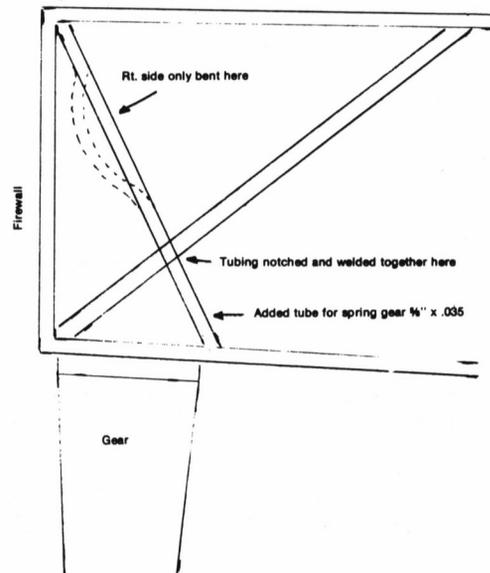
"On a third S-1S which is a factory kit airplane with factory installed spring gear, there has been a failure of the fuselage side diagonal tube which supports the aft edge of the gear. The tube is $\frac{5}{8}$ by .035 and failed in compression. A temporary fix was made by straightening the tube and installing a split outside sleeve which is bolted in place.

"Total time on this aircraft is approximately 125 hours and the failure occurred in approximately the last 40 hours. No hard landings have been made and most landings have been on paved runways."

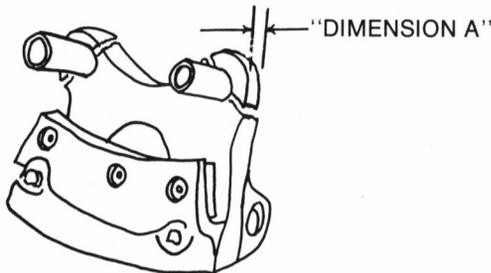
MODEL 30-9
MFG. 12-73
CLEVELAND

that was still several hundred feet ahead of me. The right brake pedal went to the floor; however, since the left brake was working, the Pitts swerved to the left and put me in the grass. Even though the left wing raised quite a bit, I was lucky that I did not drag the right wing tip, and once I was in the grass I regained directional control and prevented a ground-loop.

"Examination disclosed that **both** ears on the right brake had severed as shown on the sketch, and the brake assembly rotated with the disk, which shattered my wheel pant, ruined the disk, and punctured the tire, and broke the brake line.

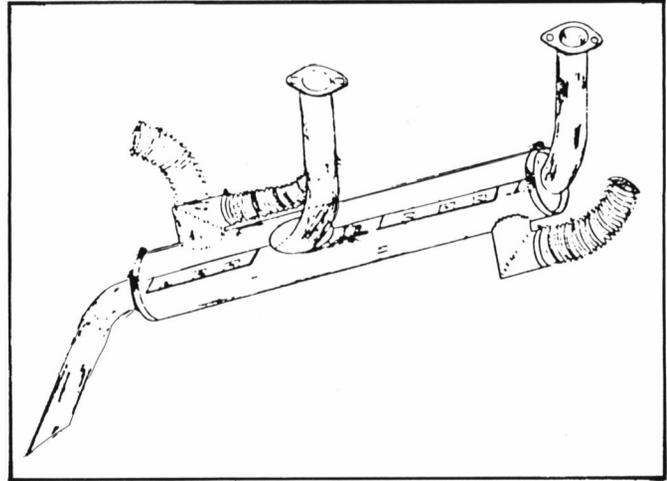
AD 80-21-06 **NOT** Applicable.

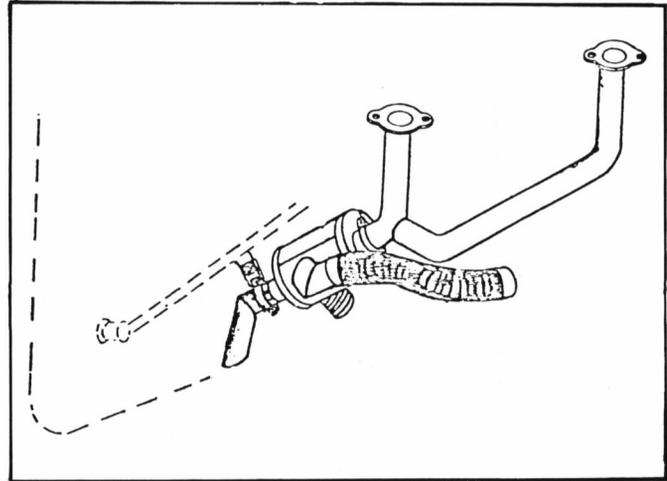
AD 80-21-06 Applies to this system.

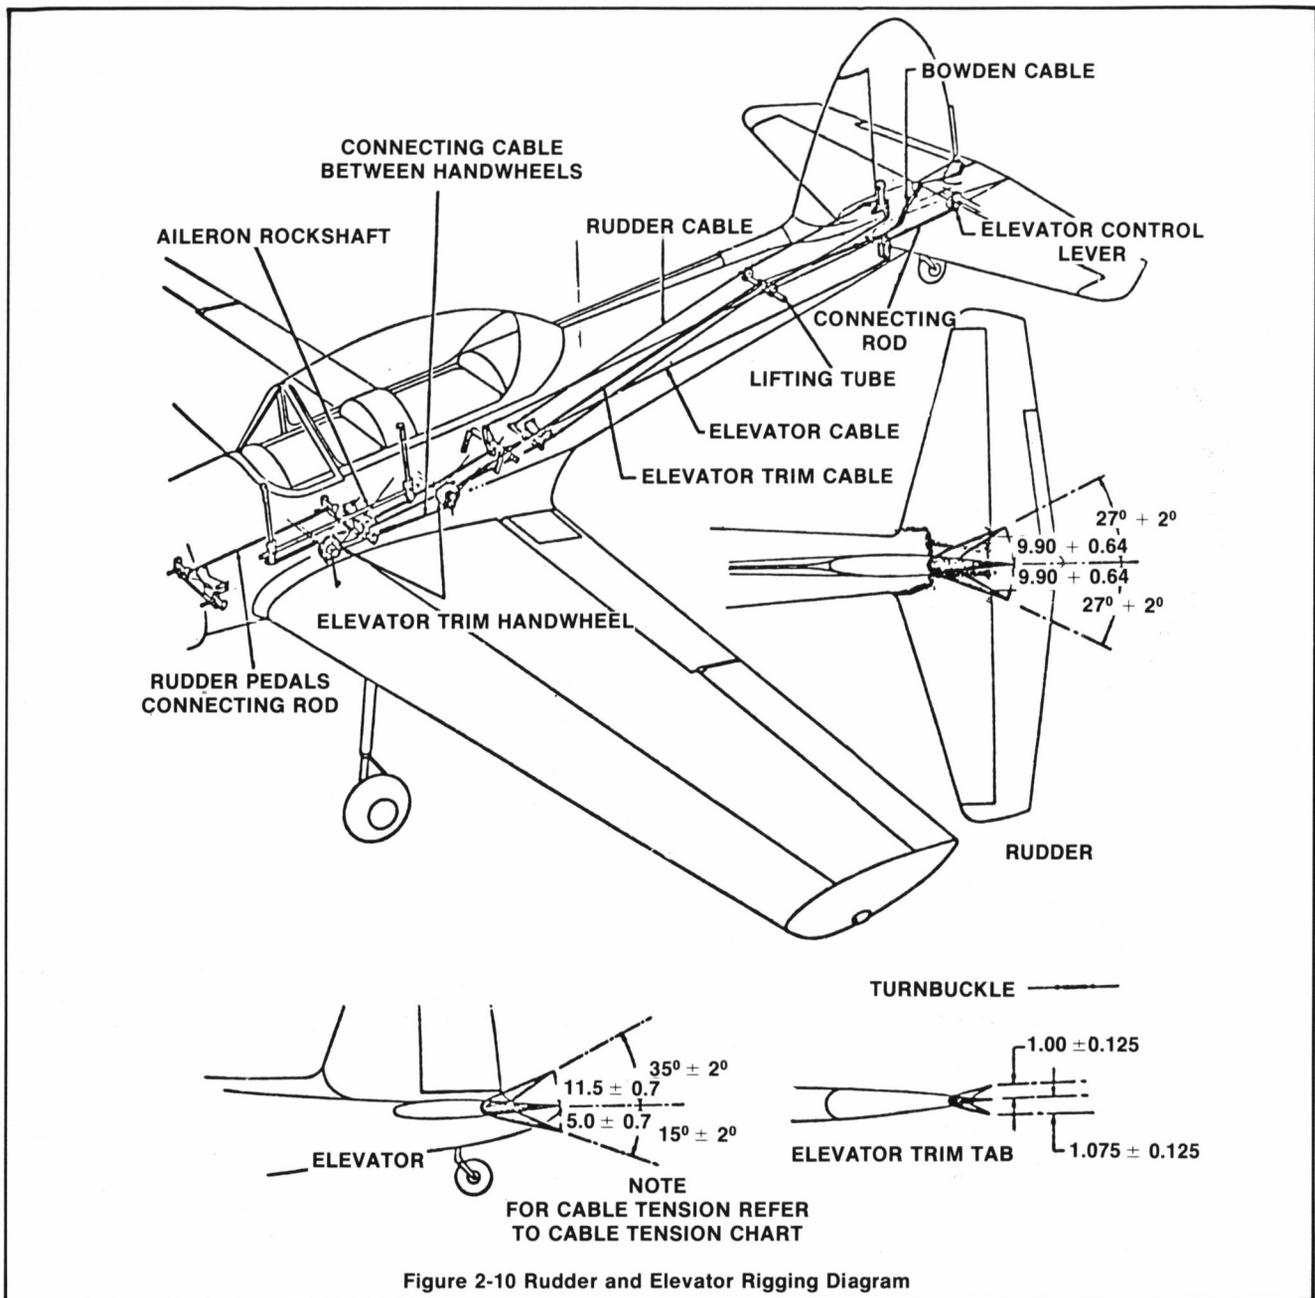
Figure 2-10 Rudder and Elevator Rigging Diagram

"The rudder spar cracked under lots of snaps. The hinge bracket tore the spar."

Corrective action was reported as "Fixed with stress plates and additional hinge."

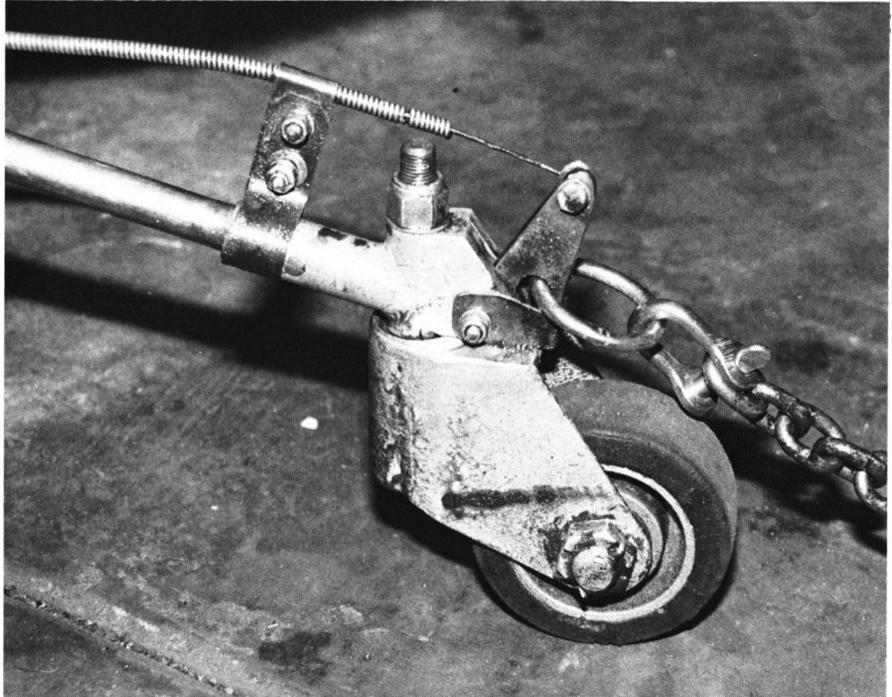
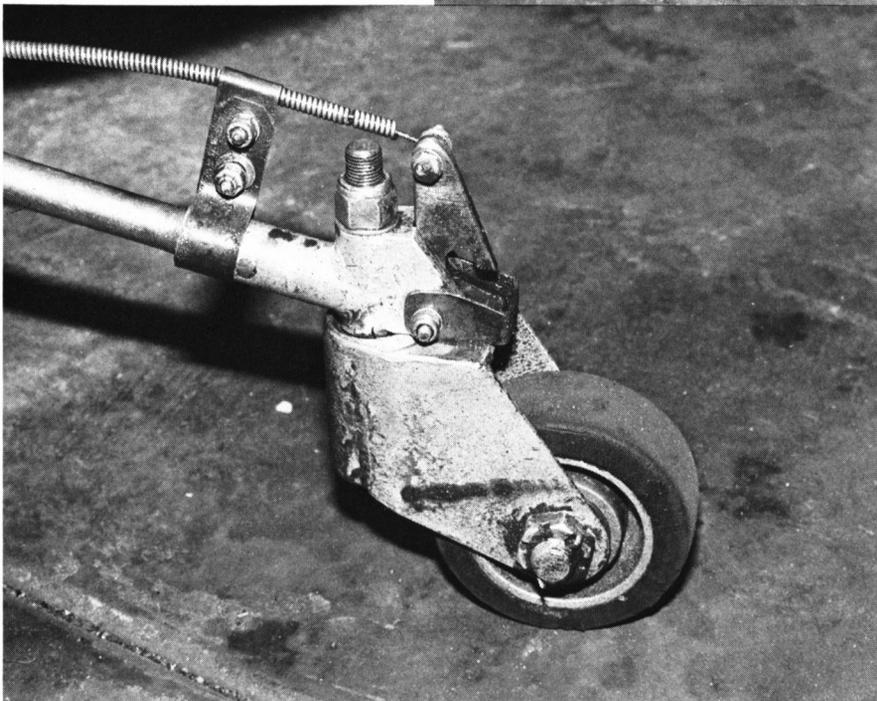
Retaining Chain in position prior to release from inside cockpit.

Tailwheel free after chain is released.

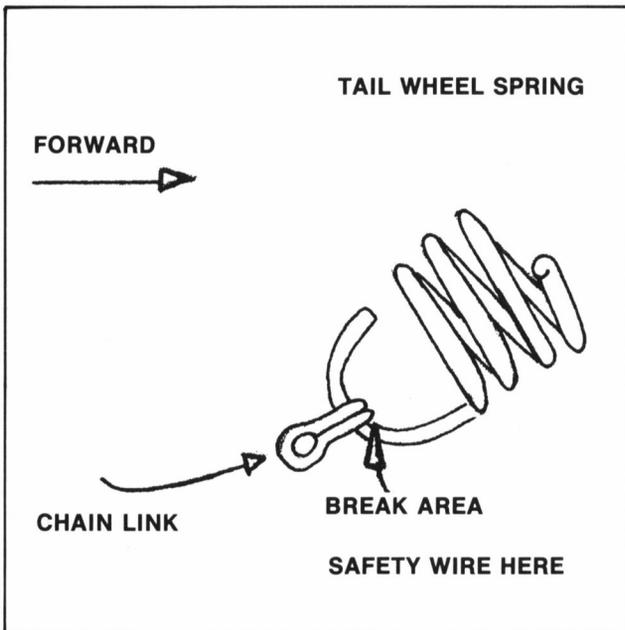
TAIL WHEEL STEERING CHAIN LINKS

"To preclude link breakage, the link that attaches to the spring (this is the one that seems to break first) is wrapped with safety wire. This is the area of more wear. The other end attaching to the teardrop clip at the tail wheel steering arm shows no sign of wear. On a Pitts this is usually a difficult area to inspect as the tail wheel assembly is usually covered with oil from the breather tube.

"While inspecting the chain links it is smart to run your finger over the sheet metal screws (three on a Maule) under the kickout pin as these have been known to drop out allowing the pin retainer plate to separate thereby rendering the steering mechanism inoperative. This has been corrected in later models with bolts."

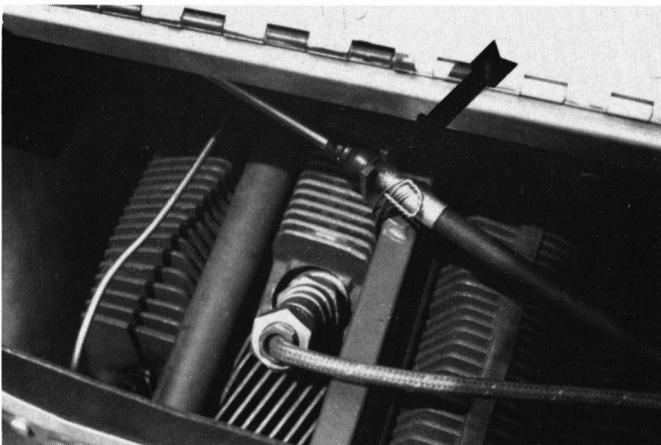
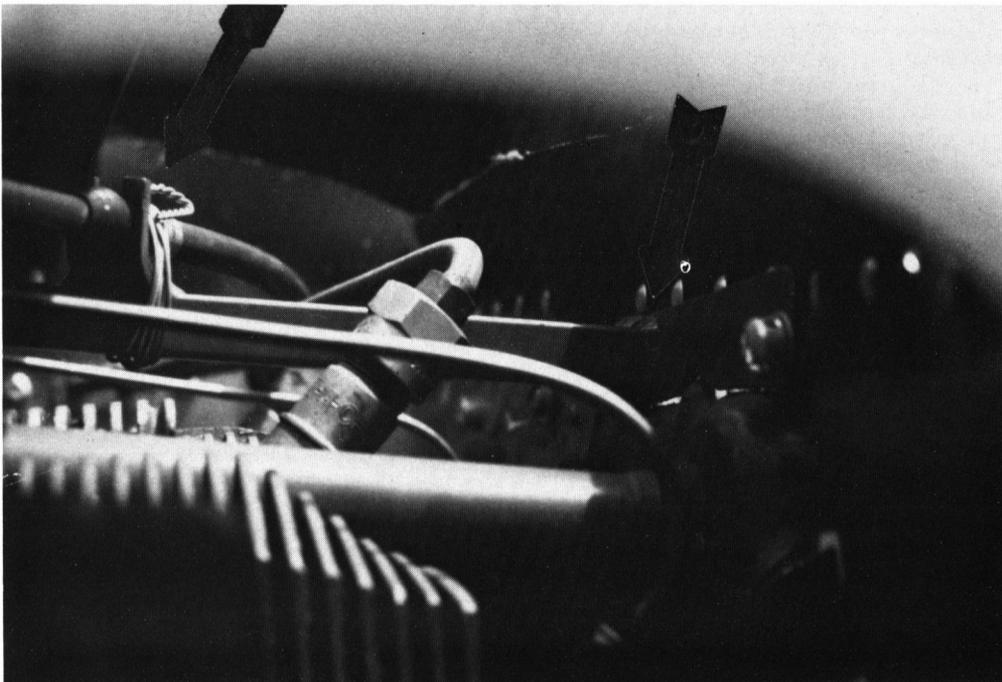
"While flying hammerheads I noticed RPM had changed after each maneuver. First thought was that I hadn't properly tightened the propeller control, but the problem continued and the control had a soft abnormal feel. Problem was identified when the prop control cable housing was found to have lifted out of its forward attachment, a U-shaped bracket which engages a slot in the end of the housing. We safety-wired the cable down and thought that was the end of that.

"The RPM started drifting again to prove us wrong. This time the strut holding the bracket for the cable had broken loose at its outer end, through a weld. The strut passes side-to-side over the front left cylinder. It's easy to remove and fix."

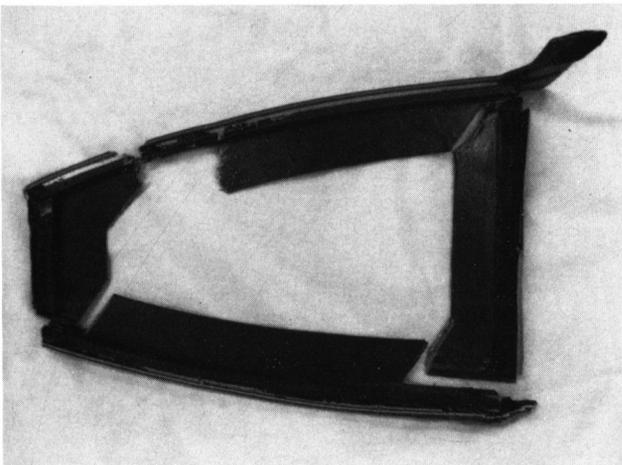
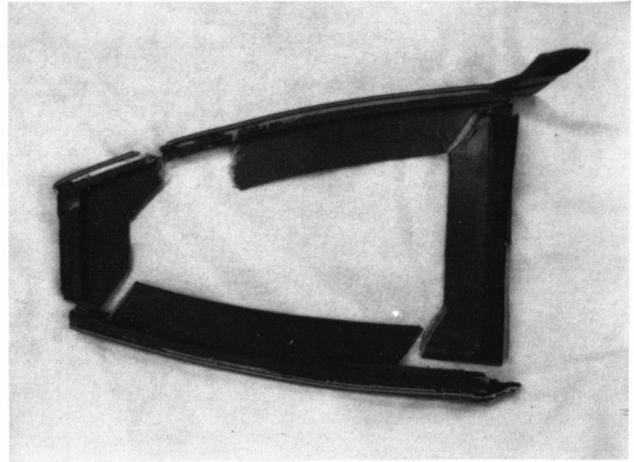
"While practicing for the Nationals last year, some small cracks in the skin started showing up just ahead of the spar and at the same time I noticed some small tooth-pick-sized pieces of wood coming out of the drain holes. The wing was deskinned during the winter for inspection. Total time on the wing at that time was 100 hours.

"Some early Stephens wing drawings showed a round lightening hole in the ribs with a minimum edge distance of $1\frac{1}{8}$ ". A later drawing changed from round holes to a square cutout with a minimum edge distance of $1\frac{1}{8}$ " all the way around. The latter is a poor design as evidenced by my failure. The ribs should either have the round holes or be of a truss-type construction."

To comment briefly on Henry's article, IACers should note that IAC Tech Safety files reflect wing rib failures at the corners of the rectangular lightening holes, similar to the accompanying photo, on routed plywood ribs that have been used on some homebuilt Pitts aircraft. Also, cracks have been reported on Citabria and Decathlon aluminum ribs starting at the corners of the rectangular lightening holes. And, the butt rib on the RV-3, which has a large rectangular lightening hole. Trying not to take things too far out of context, an old (1925) NACA Report on the design of airplane ribs notes that ribs which have rectangular lightening holes usually reflect a poor strength-to-weight ratio when compared to other types of rib construction.

We have often noted that although some of the IAC T.S. reports are directed mainly to a particular aircraft, IAC members who operate aircraft of a similar design or construction to that of the a/c in question can benefit greatly from this input. Perhaps one very general conclusion that can be drawn from the above is that if you are operating an a/c which uses ribs (either plywood or aluminum) with rectangular lightening holes, keep a close watch at the corners of those holes for this is the area that is most likely to show signs of failure first.

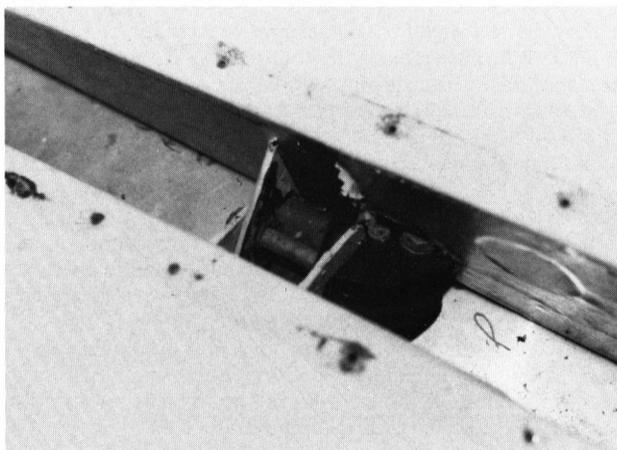
"I am not sure if this was done to eliminate vibration or was an oversight on the part of the builder or what. But I called my mechanic and we proceeded to put the wing back where it belonged. Would you believe we just simply loosened up the front wires six turns, pushed the wing right in place, and I put the bolt through all of the fittings with my fingers. Absolutely no slop in the fittings whatsoever. I tightened up the front wires and test-hopped the airplane. You can't imagine what a difference this made in the performance of this airplane. The right

What do you think of this? Over 460 hr. on this wing fitting. I checked with the previous owner, they had never touched a thing.

"Enclosed is a picture of just the way the fitting was found — might be worthwhile to pass on."

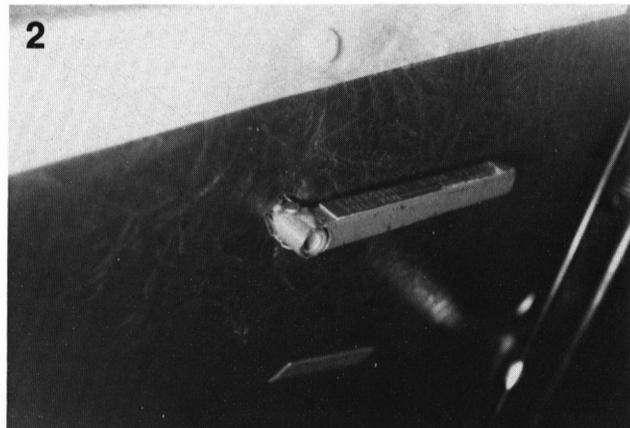
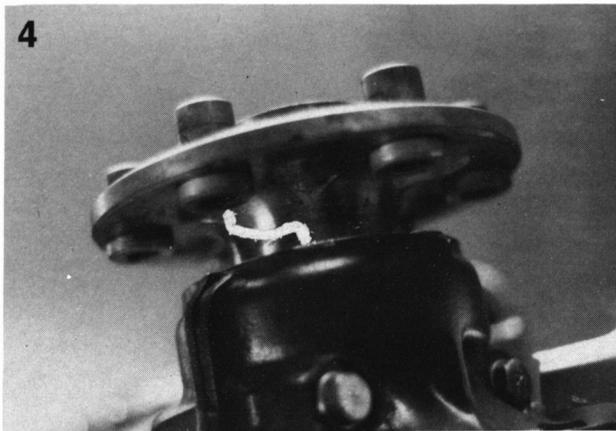
IAC contest rules require (and good sense dictates) the use of dual set belts **with separate attach points**. Several years ago a Pitts S-2A showed up at a contest with both belts attached to the same bolt. Last summer a Decathlon was observed to have the same belt attach arrangement. (Photo #3)

Cracked crankshafts/crankshaft flanges have been a reoccurring problem on high performance/upper category acro aircraft. This year at the IAC Fond du Lac contest another cracked crankshaft (on a Pitts S-1) was discovered. (Photo #4) Perhaps periodic dye penetrant checking of crankshafts would be a good idea for acro aircraft that are subjected to high (and frequent) loads.

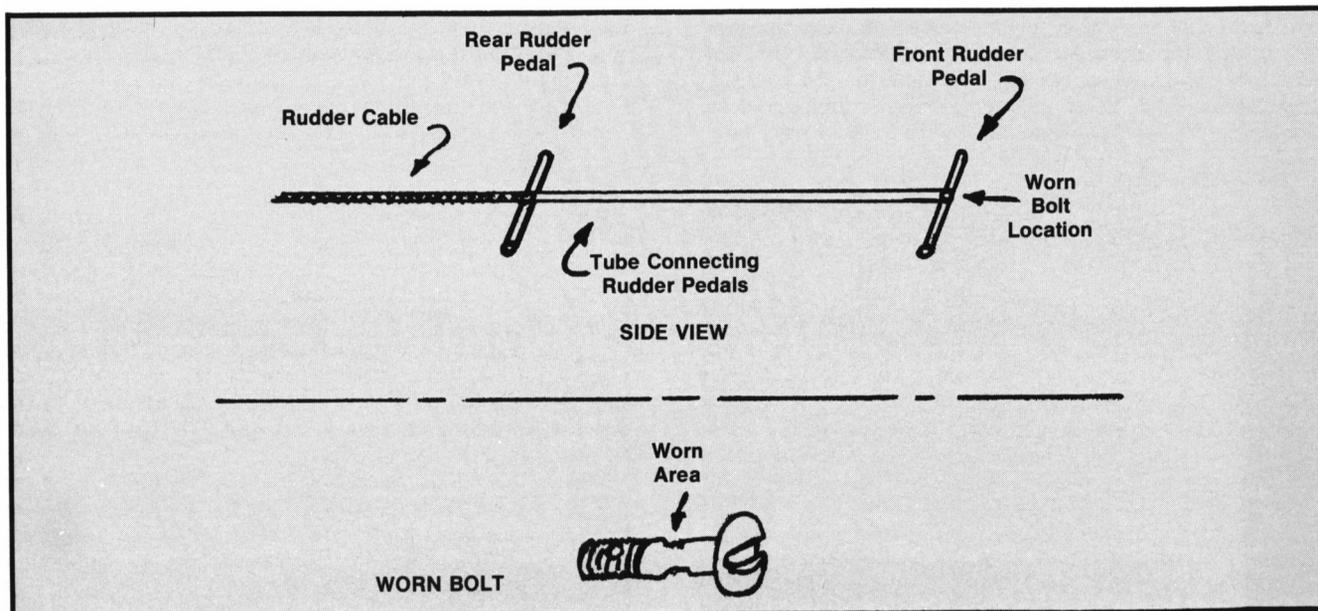
The accompanying shop sketches and photograph show the location of a severely worn rudder linkage connecting bolt that was forwarded to the IAC Technical Safety Committee by an IAC member. The bolt was from a late model Decathlon with approximately 1500 hrs. total time and the wear problem was discovered during an annual inspection. The consequences if this bolt had failed are

obvious. All IAC'ers who operate Citabrias and Decathlons which have the same type of rudder linkage would do well to closely inspect all connect/pivot points for wear. The IAC member who submitted the worn bolt info has previously contributed to the IAC Tech Safety Program — so, **again**, a thanks is due. Thanks.

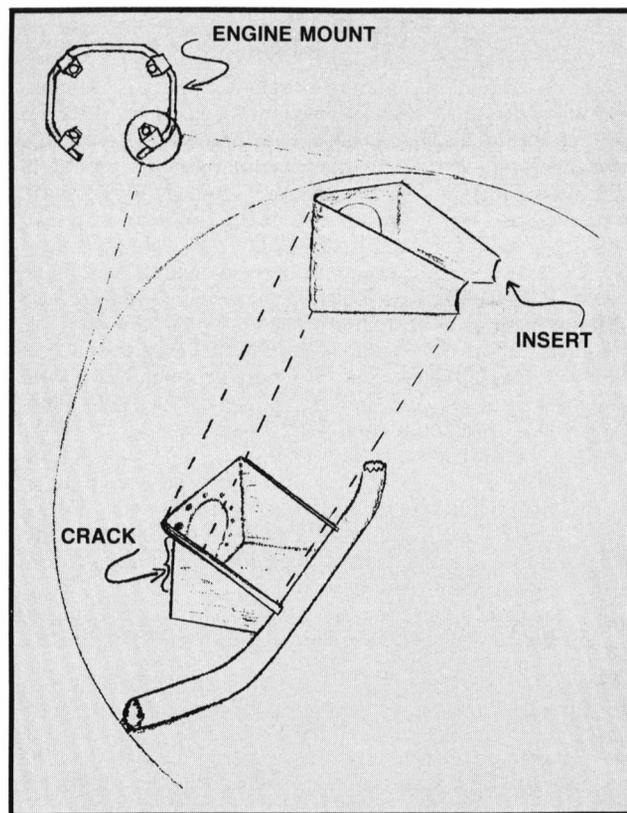
“I had heard from various sources that this mount was prone to crack in the corners of the box section which the rubber engine mounts bolt through. Sure enough, after 220 hours time a crack approximately 1½” long showed up in the welded corner of the top left box.

“At any rate, any Great Lakes owner, particularly aerobatic competitors (and all tech inspectors), should be aware of this flaw. It can occur in an area that is difficult to see and will only be noticed upon very close inspection. Needless to say, if this condition were allowed to progress, the results could be disastrous.

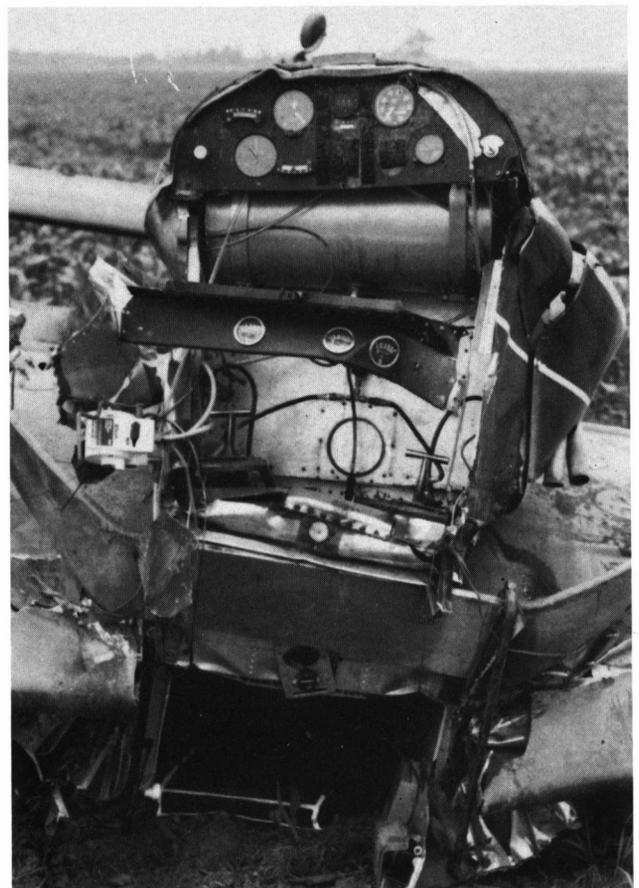
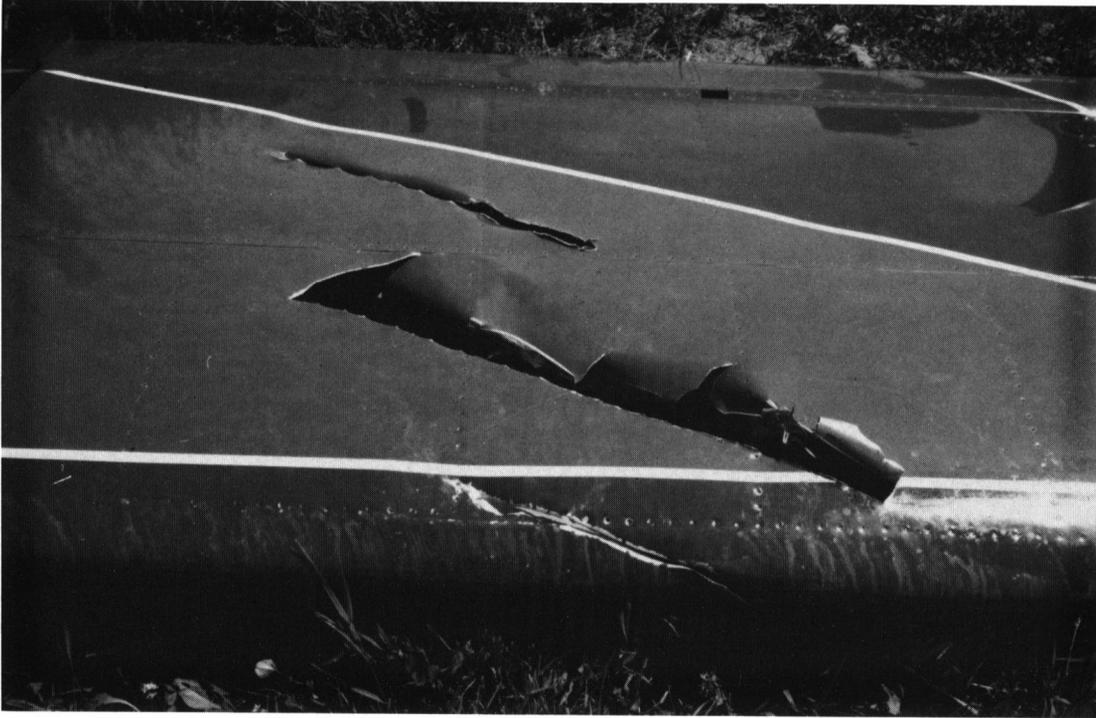
odor of burning wood and, wary of the propeller, throttled back some and began to turn for home. Suddenly, without further warning, the propeller left the aircraft, coming off diagonally to the right, cutting three slices through the upper wing skin as it went by. John's impression was of the fiberglass cowling exploding to bits. He does not remember cutting the throttle, but must have as the engine suffered only minimal overspeed damage.

The aircraft commenced a steep glide with a sink rate John estimates of 1,700 feet per minute. He attempted to jettison the canopy but in the excitement, broke the emergency release handle. The sideways opening canopy opened and came to rest on the left wing. The sink rate being much higher than anticipated, John abandoned an attempt to reach a road and selected a soft cornfield on which to land. The corn stalks were about 12 inches high and he came in across the furrows. The aircraft struck flat on all three walls and bounced, turning over and coming to rest inverted about 35 feet from the point of initial impact. The shock of the first contact was such that the main landing gear attach fittings tore the fuselage sides upward and fractured the upper longerons so that everything forward of the wing flipped under the aircraft and came to rest on the underside of the wing, miraculously creating an escape route from the cockpit as you can see from the enclosed photographs.

"The ensuing investigation revealed that the bolts had failed, due to high cyclic load of short duration. Evidence suggests that the probable cause was a loose assembly, possibly the results of the bolts shouldering in the flange.

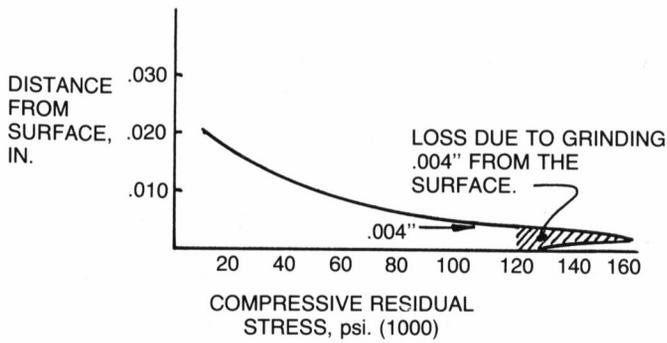
FIG. 1

"The fracture surface of the crankshaft indicates that failure was primarily due to a bending fatigue load with minor influences from a torque load. The crack initiated at the end of a reground area adjacent to the fillet that blends the No. 4 crankpin to the cheek surface. The stress that caused the crack to initiate was tensile, caused by firing pressure loading.

"The crack initiation portion of the fracture surface is multi-faceted, meaning that the crack started from many sites, about the same time. This type of crack initiation is indicative of a high mean stress relative to the available strength in the shaft. The crack started at the surface, at the end of the reground area, then propagated into the cheek and back out into the remaining part of the pin body. From the fracture surface one can observe the depth of nitriding on all exposed surfaces including the lightening hole in the pin body. CAUSE OF FRACTURE: STRESS EXCEEDED AVAILABLE STRENGTH . . . Why?

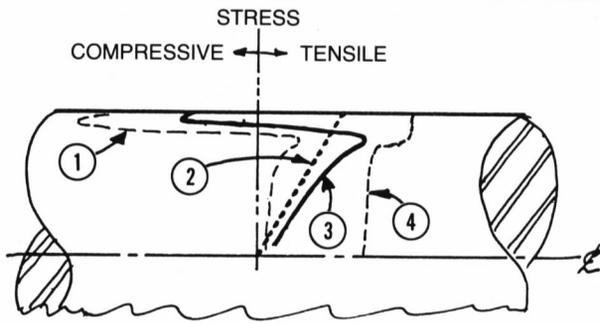
FIG. 3

"The algebraic relationship between stress and strength distributions are major concerns to design engineers. Ideally, the goal is to reach a condition where stress never exceeds strength, as illustrated in Figure 3. In Figure 3, if any portion of (3) (stress) exceeds any part of (4) (strength), failure will occur. It can initiate subsurface as well as at the surface. A surface-initiated failure is shown in Figure 4.

- (1) Residual stress distribution due to nitriding
- (2) Stress distribution due to external load
- (3) Resultant of (1) + (2), algebraically
- (4) Strength limit of material

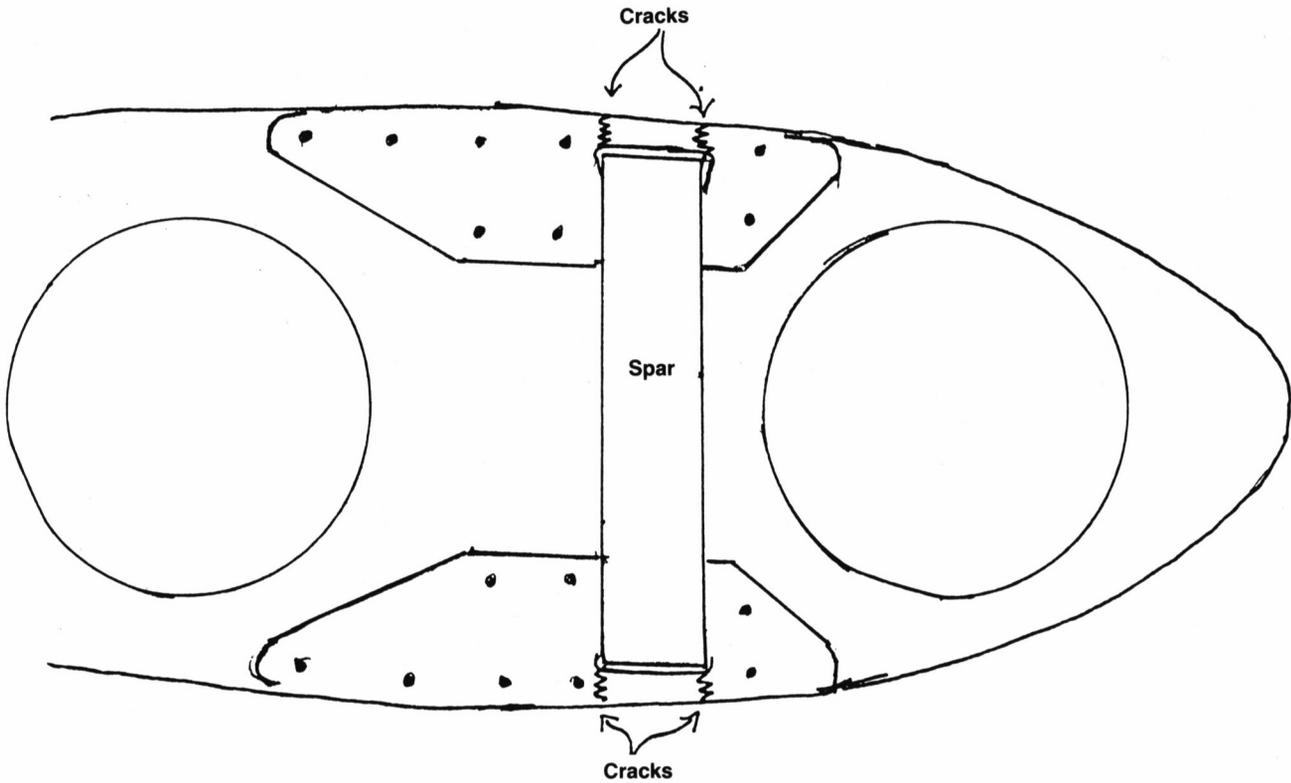
This is approximately the type of compression member that was described to me as being a better alternative since it would give torsional rigidity.

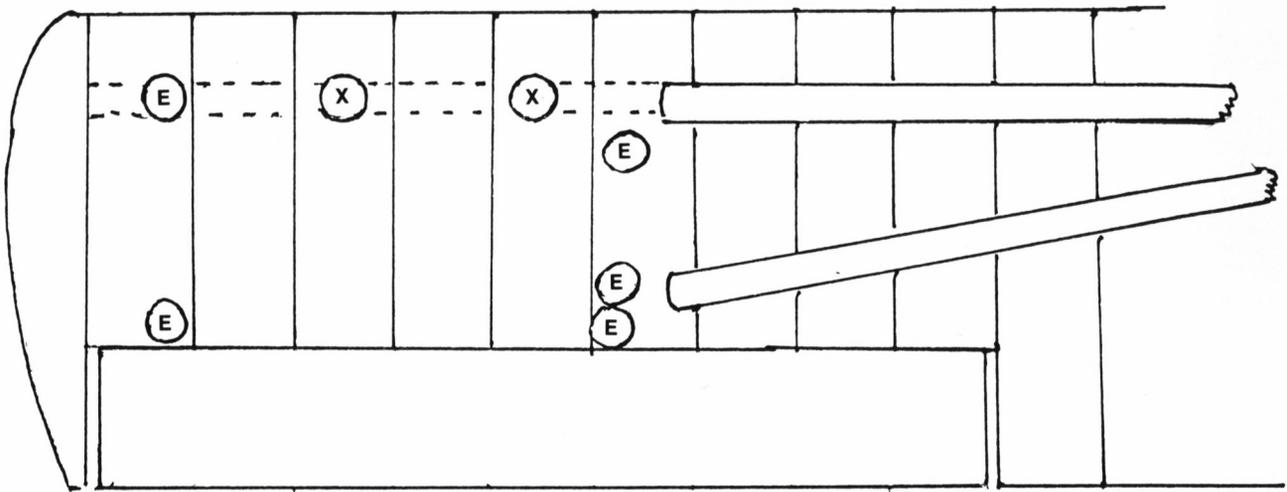
Add Inspection Covers Along Spar Marked With (X) Covers Marked (E) Already Exist.

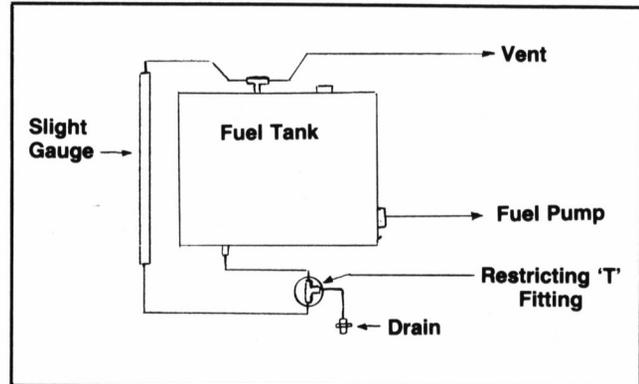
"When I was building my Pitts, I added a bottom-of-the-tank fuel drain to the fuel system by running a hose from the bottom rear tank opening down to a bulkhead "T" fitting about 6" aft of the firewall, as shown here.

"The sight gauge has been unreliable — the fuel level would vary considerably, and could not be counted on to return to the same place after a maneuver, or even after draining fuel on pre-flight. I always thought that I had too much hose length to allow it to work properly. Finally, I decided to alter the system so that the bottom of the gauge was connected to the bottom of the tank by aluminum tubing, hoping that would improve the action. In the process, I removed the "T" fitting (circled) and put a regular (not bulkhead) fitting in the bottom of the tank. Thought I would look for obstructions, so blew through the hose (O.K.) and looked at the fitting. VOILA! One-quarter inch down in one side of the old "T" fitting was a tiny metering orifice! A constant, accurate, and totally unwanted restriction. Once again, the light that says 'DUMB' lit up. I had installed this fitting several years ago, before I knew that the first thing to do after buying, and the last thing to do after buying, and the last thing to do before installing, is to check for restriction. So, now I can once again try to calibrate my sight gauge, with the hope that it will be accurate this time."

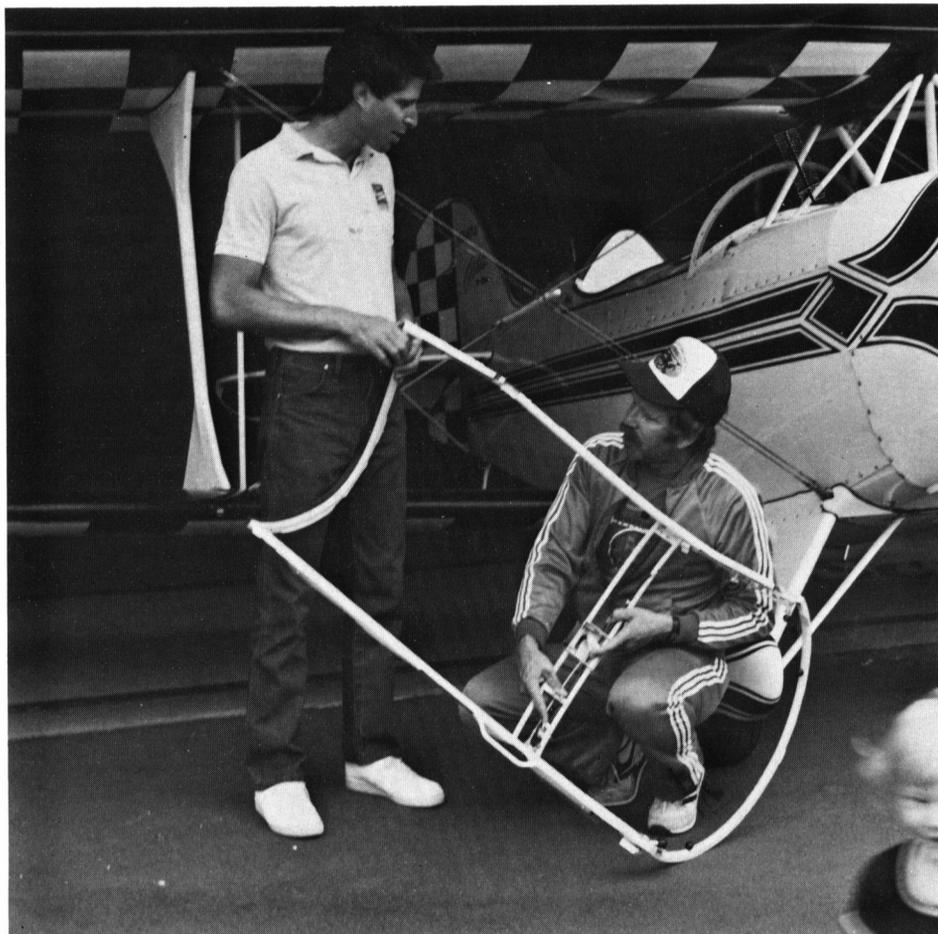
Charley Larkey and I examine recovered canopy frame to see if we can find any reason for it coming off.

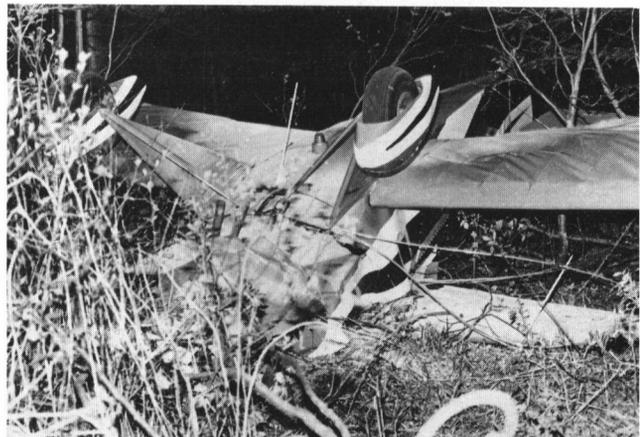
Skybolt crashed during inverted spin.

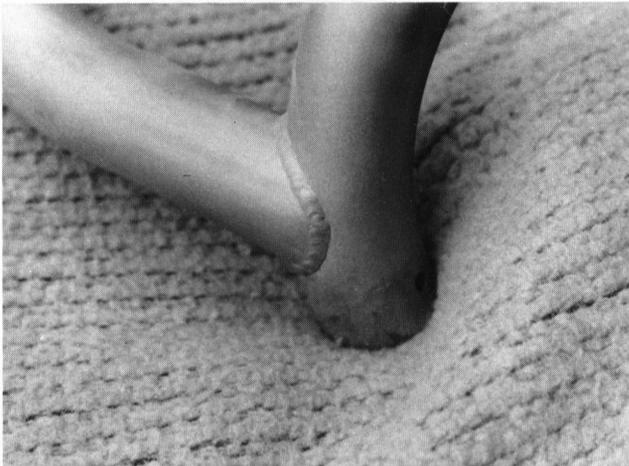
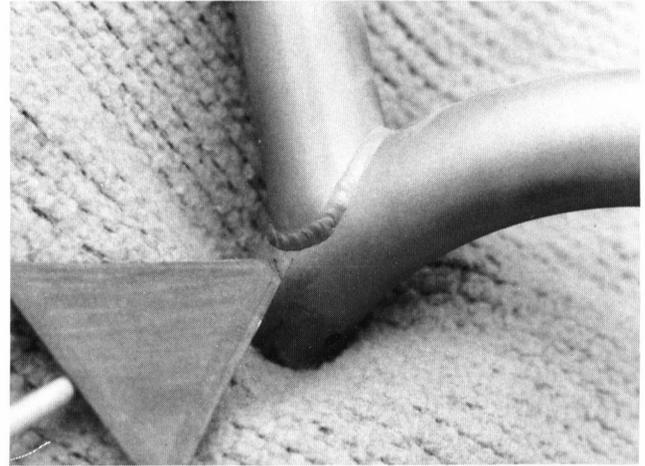
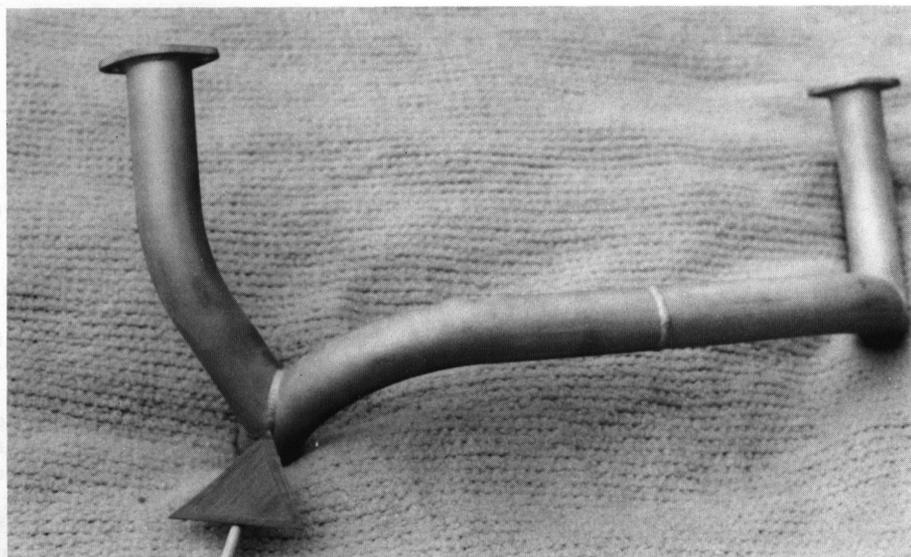
This Citabria's exhaust system is of the "cross-over" variety, i.e., where cylinders 1 and 2 are connected to a common pipe and cylinders 3 and 4 are connected to a common pipe. The IAC member making this report felt that a slip joint should have been incorporated into each of the long "side-to-side" exhaust pipes to relieve some of the strain on the joints — for example, the area where the crack was found. He believes the pipe will probably fail again and probably in the same area where it failed this time. He also felt that .040, although a common exhaust pipe wall thickness, was a bit on the small size and would have preferred a heavier pipe.
